# Inspection Report

## Oregon Metro

**Property Address:**  
2517 SE 82nd Ave.  
Portland OR

<b>Date:</b> 10/17/2014	<b>Time:</b> 10:04 AM	<b>Report ID:</b> 20141017a
<b>Property:</b> 2517 SE 82nd Ave. Portland OR	<b>Customer:</b> Oregon Metro	<b>Real Estate Professional:</b>

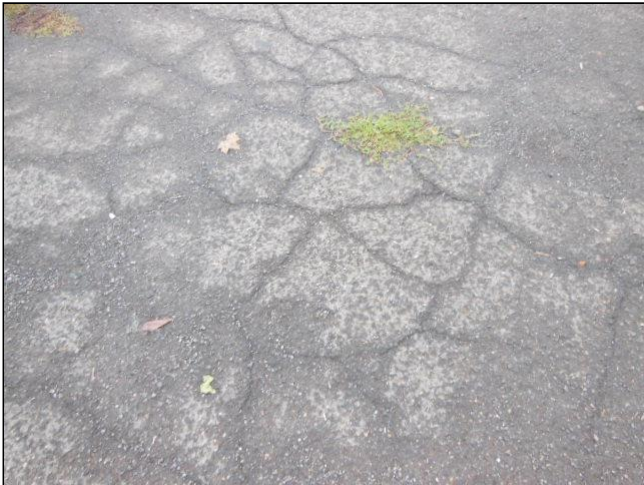
C. Item 2(Picture)

asphalt pavement overdue for patching and seal service.

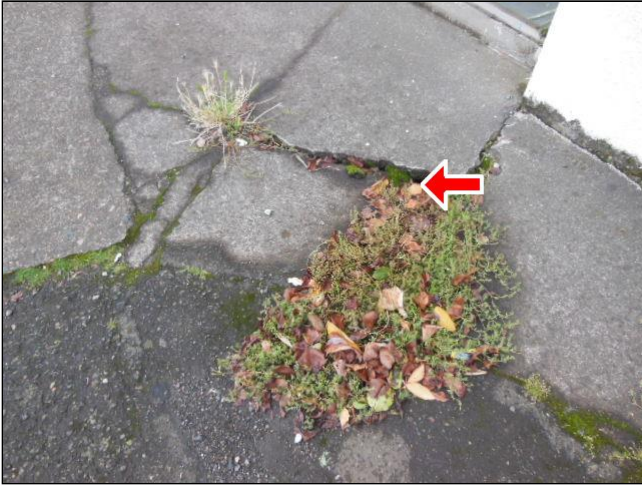
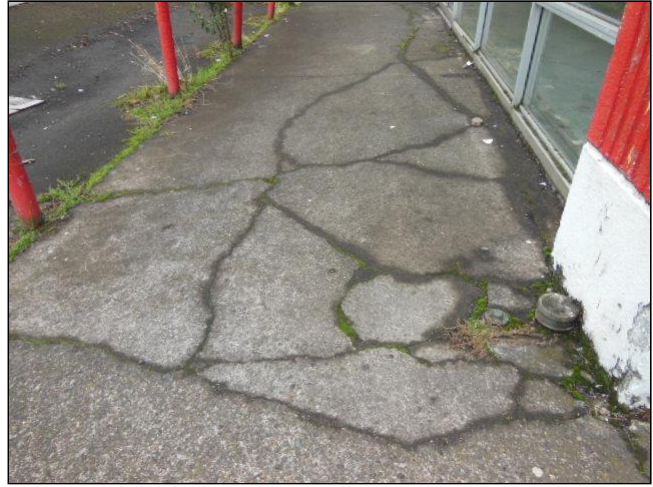
concrete walkway at front damaged, can be a trip hazard (near 82nd entrance)

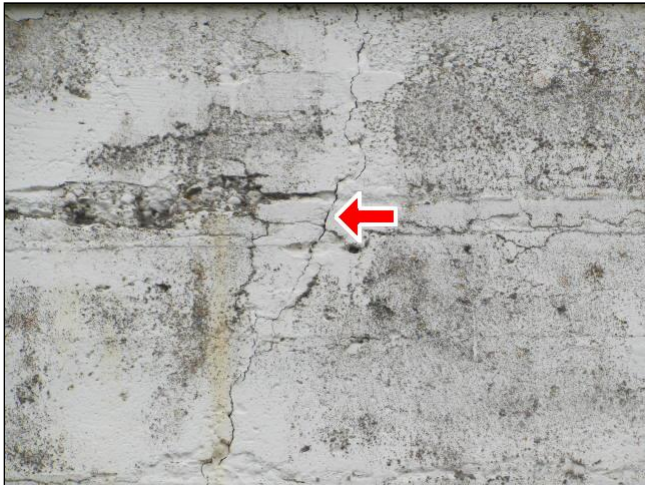
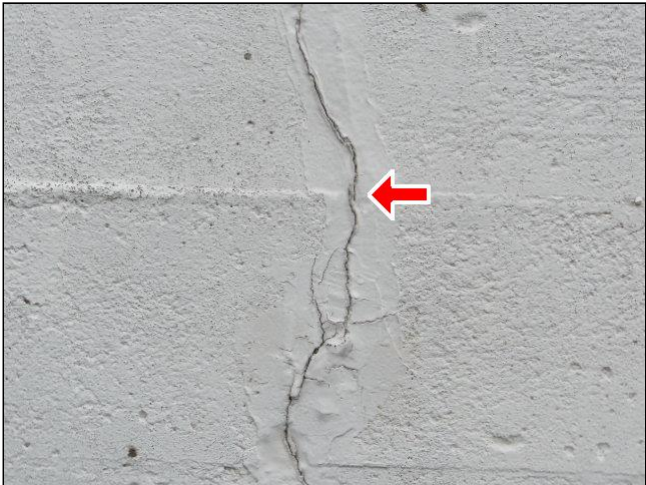
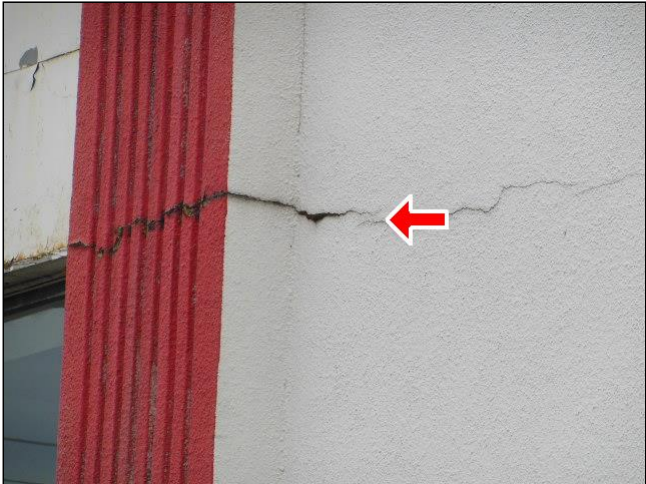
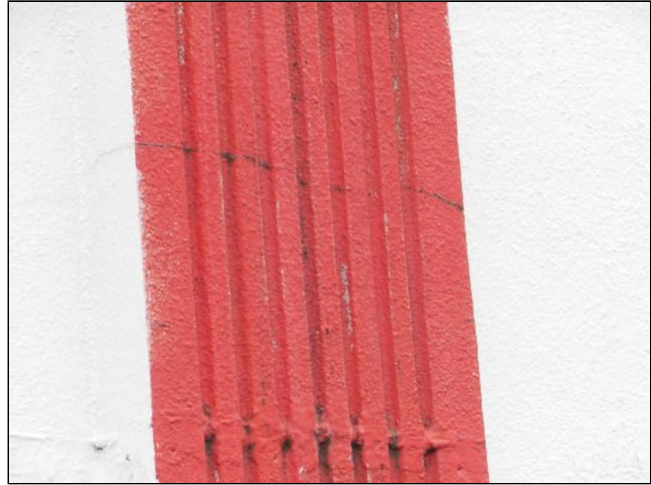
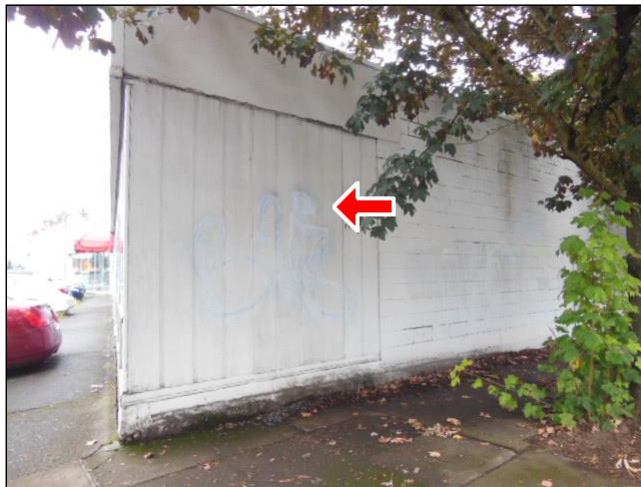
(1) Hairline settlement crack (typical) at exterior. These cracks do not appear significant to require repairs at this time. I recommend a structural engineer inspect further and repair if needed.

vertical cracks at the rear of the building do not pear in our opinion to be significant. There appears to be a horizontal crack across the front of the building (along division) Building section #1. This may only involve the exterior stucco but it may be more significant. Unfortunately, it is unlikely that This condition can be evaluated any further through non destructive means. Removal of a portion of the stucco and some of the interior framed out, lath & plaster wall may be necessary to get any better evaluation of this crack.

Infrared analysis of the crack from the building exterior does not show much entrapped moisture and therefore does not appear to be extensive.

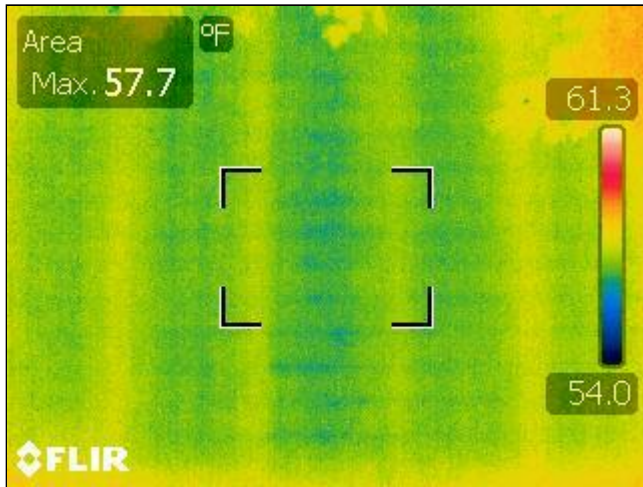
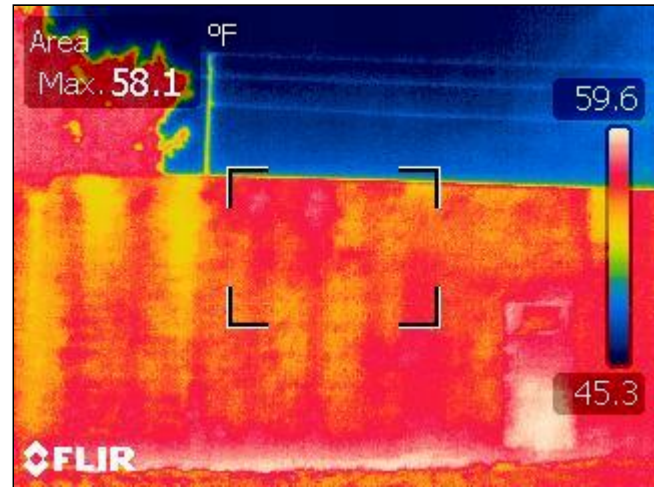
(2) IR analysis of the Block walls of sections 1 & 2 show that there are concrete filled pilasters about every 4 feet (double the normal structural pilasters).

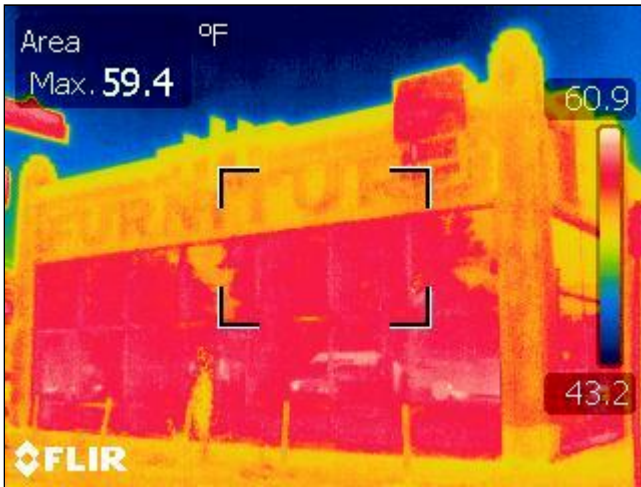
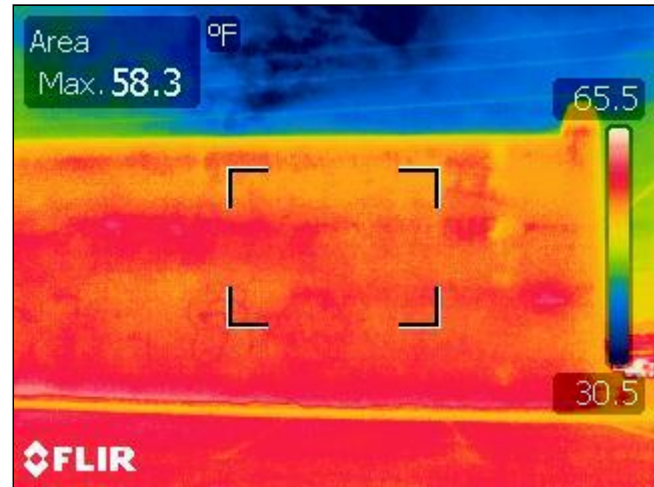
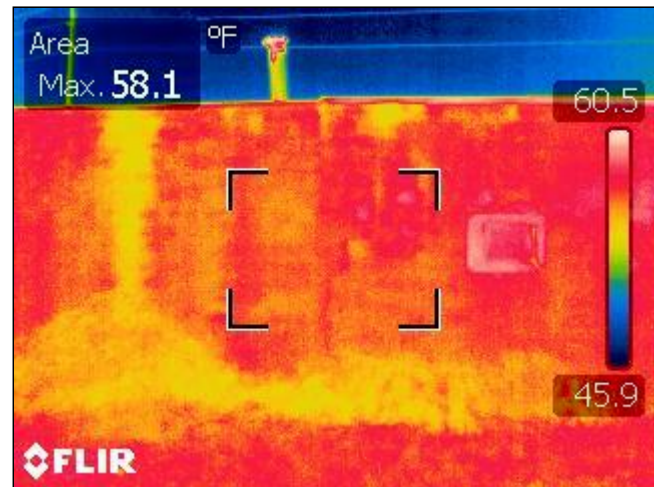
(1) the bare concrete wall and bare l'm creep block walls are in acceptable condition.

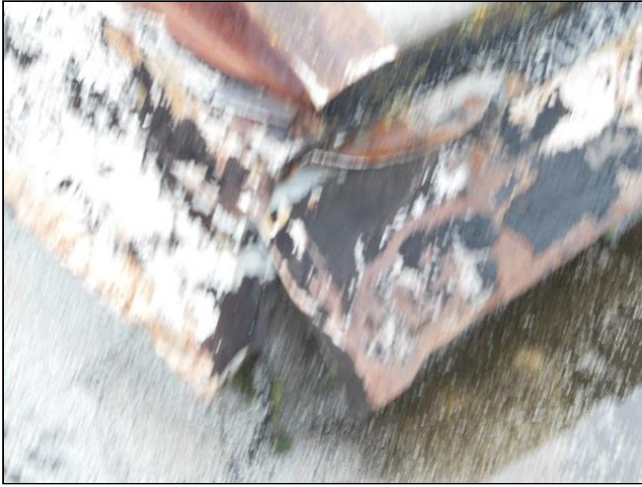
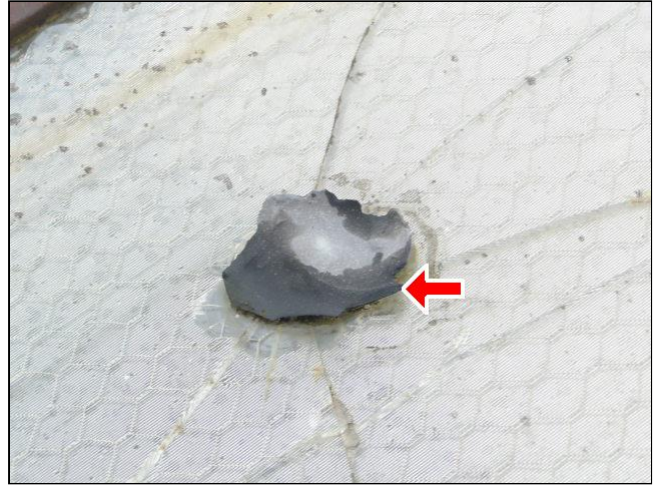
(1) skylight in roof section number 1 in poor condition, it has multiple sheet metal defects and broken glass. Some of the glass has been sealed with roofing materials. The skylight does not appear to be leaking at this time but will undoubtedly be a maintenance issue and need repair and seal service. You may wish to cover the skylight.

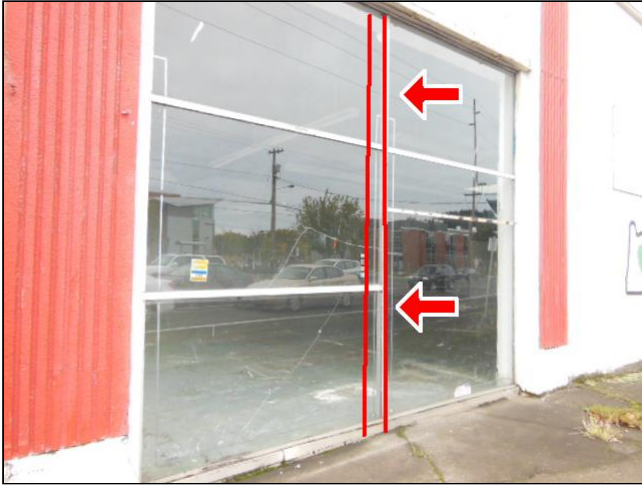
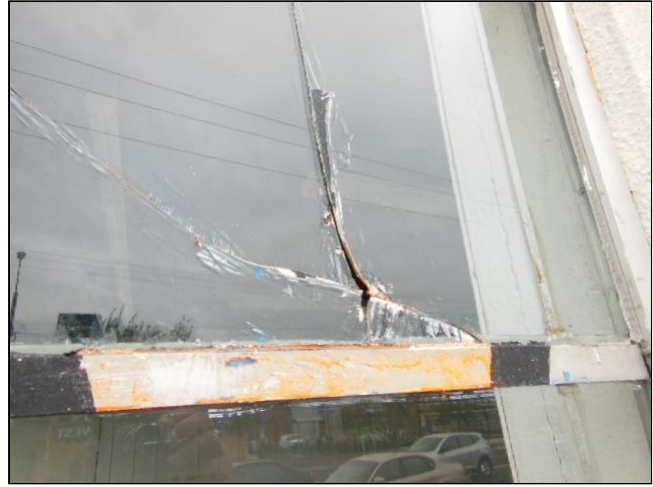
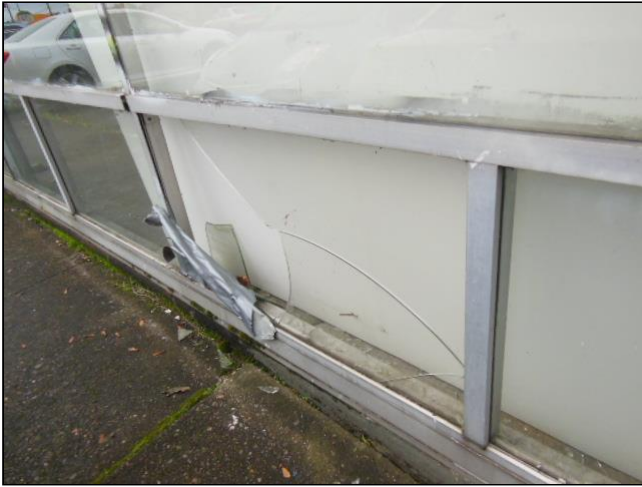
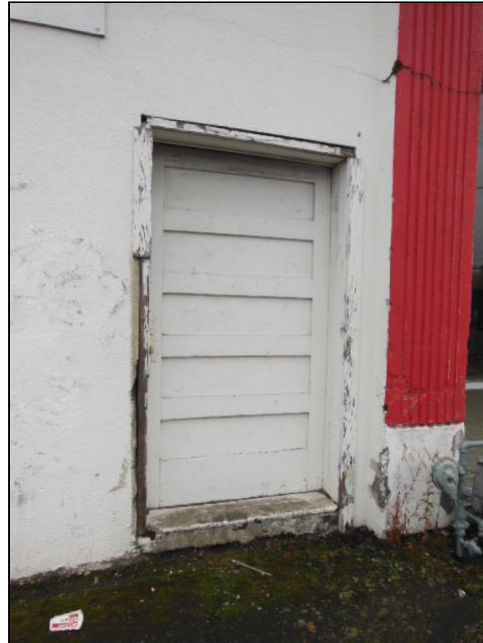
(2) The windows and window framing is substandard. This is particularly a problem on the 82nd Street section and the first section closest to 82nd and division side. Several of these windows are broken and the framework is weak, creating a hazard. We recommend framing in a support in the center section of this window and replacing the broken windows or boarding up. An alternative method of repair would be to wall off this one small section of glass window on division closest to the 82nd Street corner.

There is a door on Division side that is boarded up on the inside. It is weathered, the jamb is deteriorated and the trim is missing. We recommend the door be walled off if not to be used.

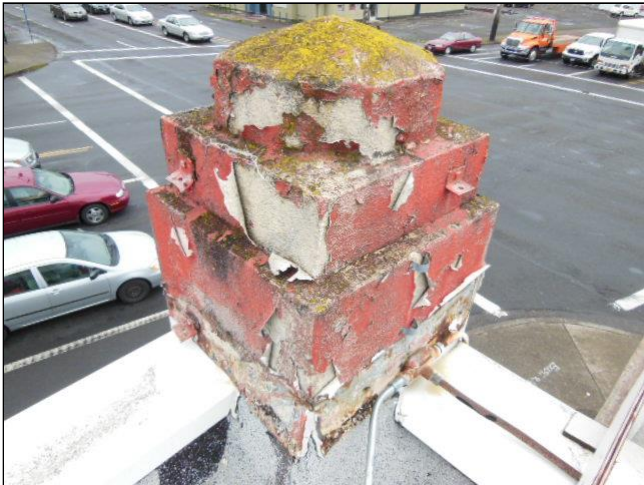
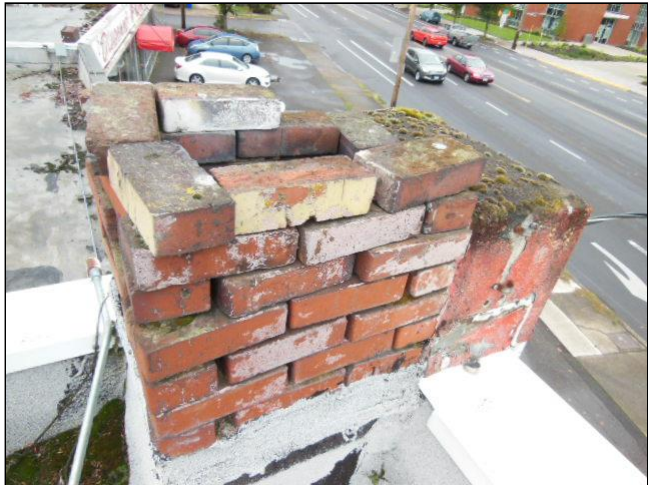
There are parapet protrusions at the roof section number 1 these are part of the stucco facade, part of the original section 1 of the structure. They all need service. NOTE: brick chimney at rear left corner (facing 82nd) is in poor condition and needs tuck point masonry service. This chimney is not in service and could be removed. (estimate is for chimney repair).

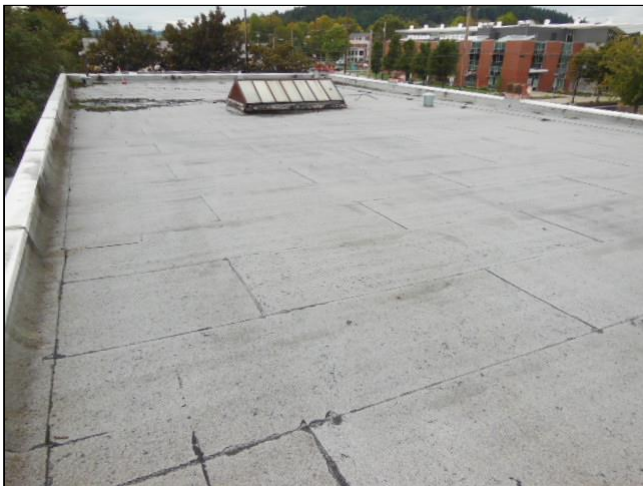
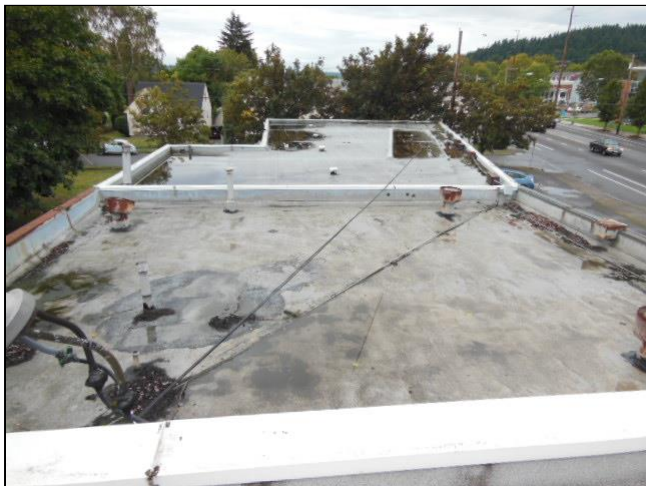
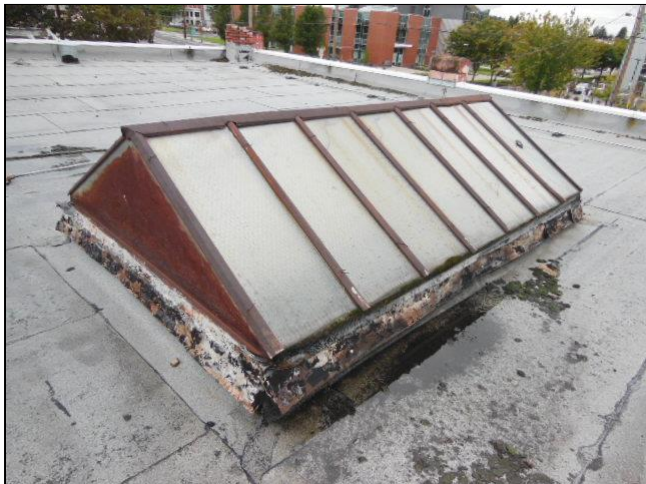
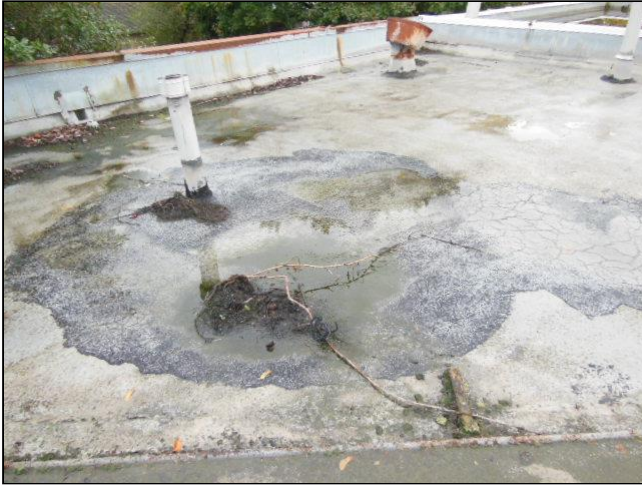
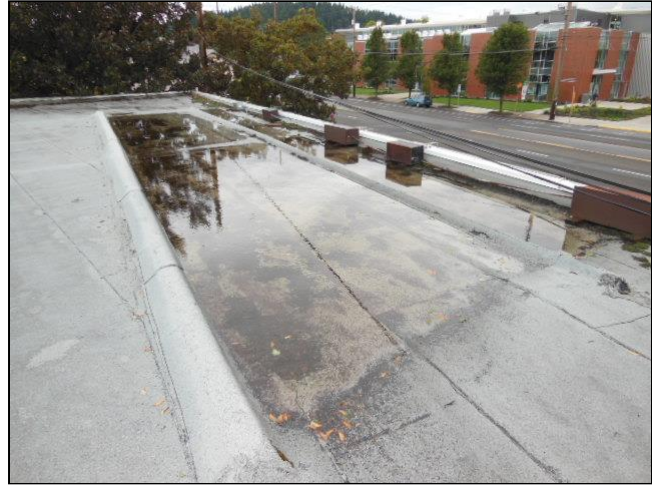
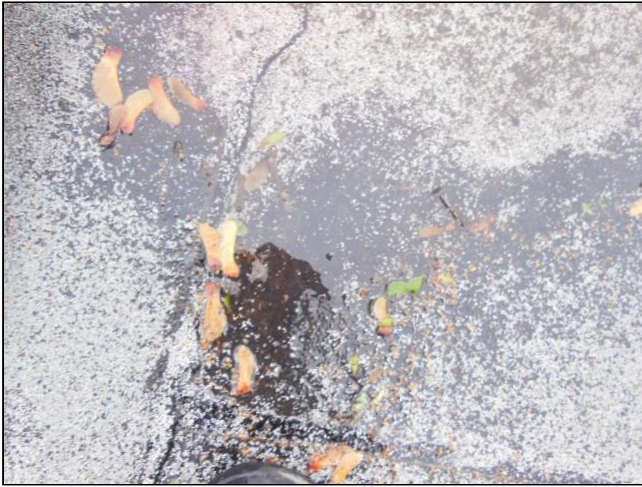
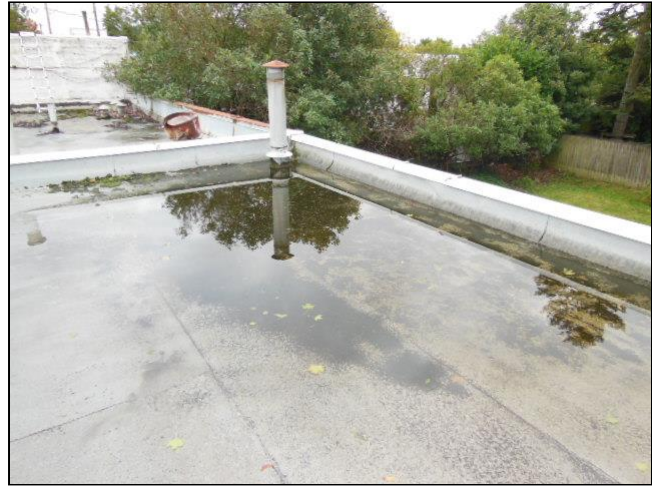
(1) There are effectively three roofs. Going west from southeast 82nd Street, section 1 roof is rolled composition or "torch down" roofing, roof number 2 was rolled composition roofing, with spray foam on top, and then roof number 3 which is rolled composition roofing similar to Roof #1. Roof #1 is currently in acceptable condition, needs minor cleaning and moss treatment. May need some minor seal service over time but should last another five years or more. Roof #2 has been sprayed over with foam roofing and has been patched several times (notable moisture stains corresponding to roof patches in interior) obviously have been some past leak issues. I can only recommend replacement of this roof area/ section. Roof #3 is in similar condition as roof number 1, however has several standing water areas that will probably need seal service more frequently.

estimate for replacement of middle section 2 and seal service to 1 & 2.

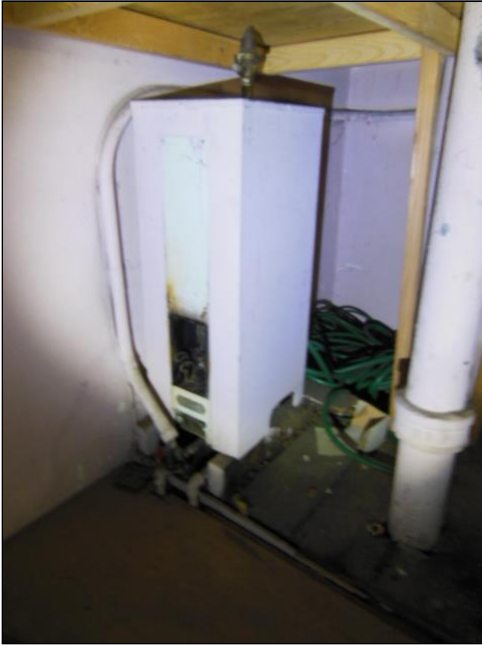
C. Item 1(Picture)

very old small on demand electric boiler system located in the mezzanine exposed wiring improper safety valve discharge do not recommend operation. Recommend replacement.

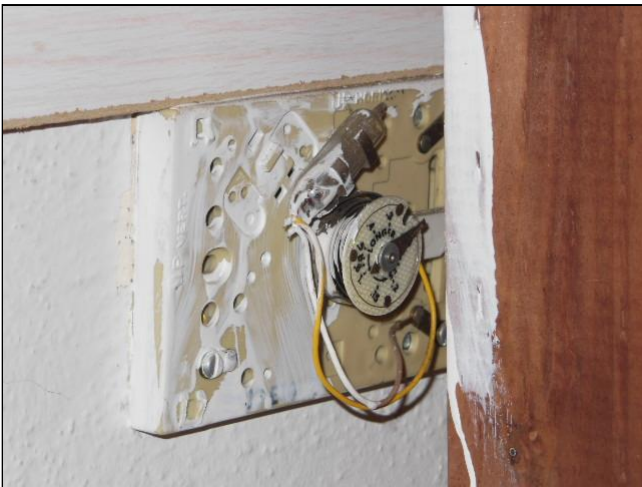
D. Item 1(Picture)

Each of the three sections are heated by an individual space heater. These units are very simple and easily repaired. However, they are more typically used in open service or warehouse areas, not areas that are occupied by personnel. The thermostat for space heater in section number 1 damaged, section 2 unresponsive; recommend replacement/ service.

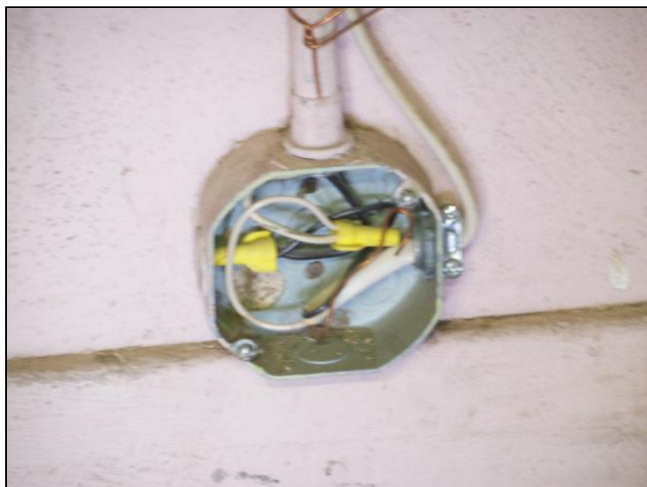
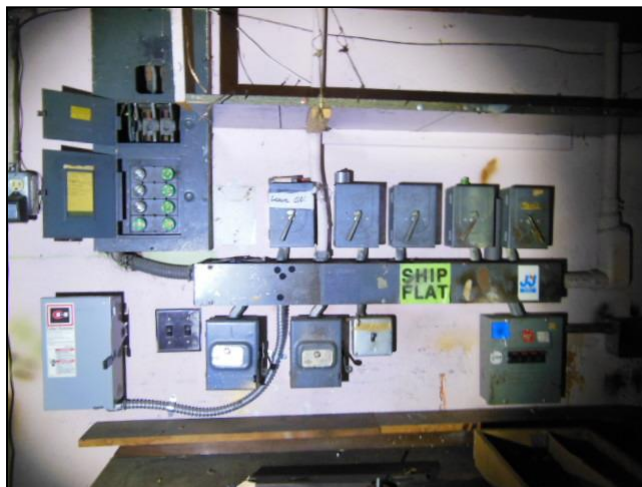
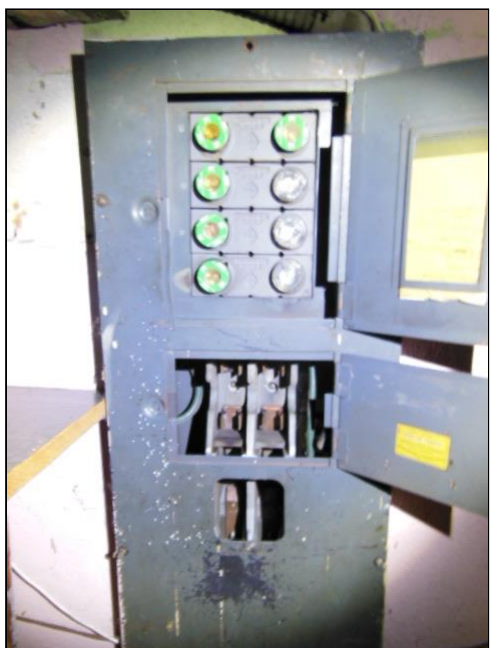
(1) Section 1 of the building served by an old fuse panel manufacturer by Coast electric. This is main is missing the main fuses so some of this is not energized. However some is connected through an old Federal Pacific sub panel and the rest of the wiring in that section is controlled by a series of older MCC station disconnects.

Section 3 is served by a 200 amp Federal Pacific electrical panel. Some of the circuits on this panel are decommissioned and appear to not properly be terminated as the panel is marked not to energize those branch circuits. The Bulldog pushmatic and Federal Pacific panels should be replaced. See additional comments about this equipment. There are a few improperly terminated branch circuits and uncovered junction boxes. The electrical distribution system should be evaluated and repaired by a qualified electrician.

(3) The main electrical panel was manufactured by Federal Pacific Electric Company and employs Stablok breakers and other components that have been alleged to be defective. However, the panel is old and the company is now out of business. There is considerable information about these panel on the internet, most of it not good news. You should look it up yourself and make your own decision how to proceed with the advice of a reputable licensed electrician. Our best advice is that the panel(s) be replaced.

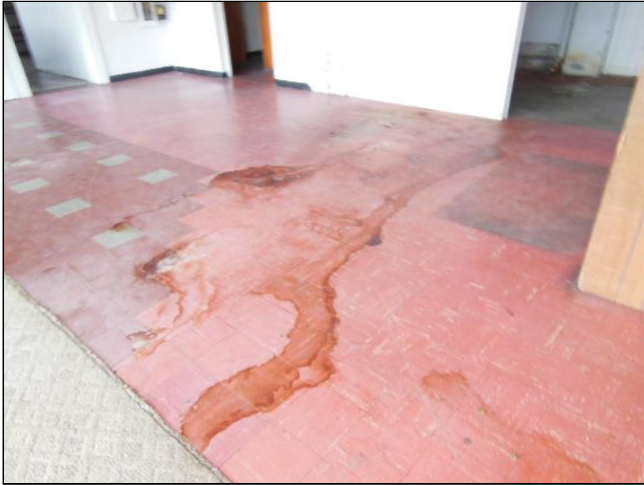
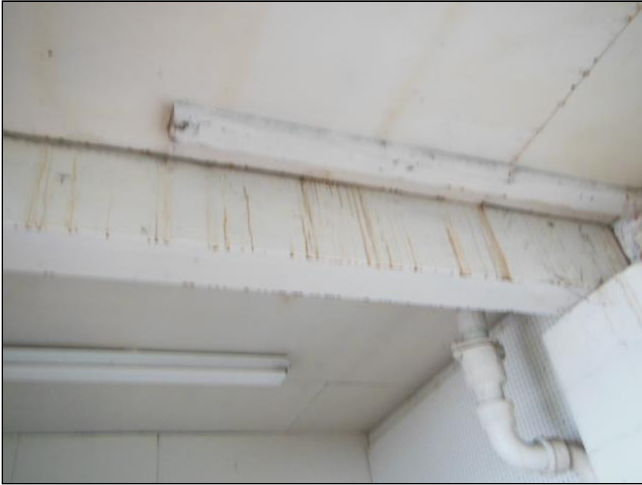
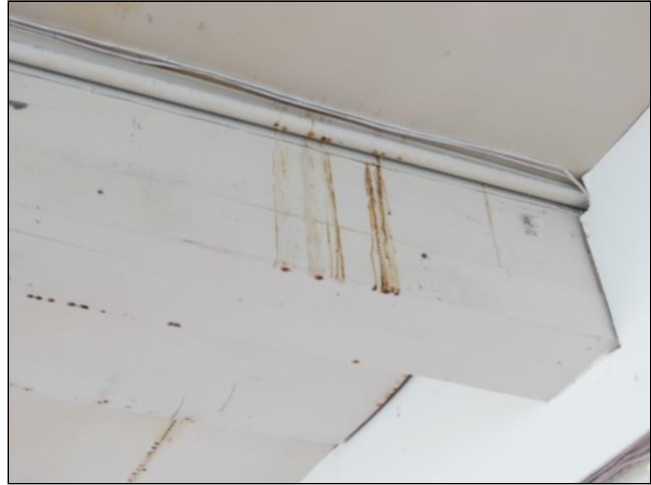
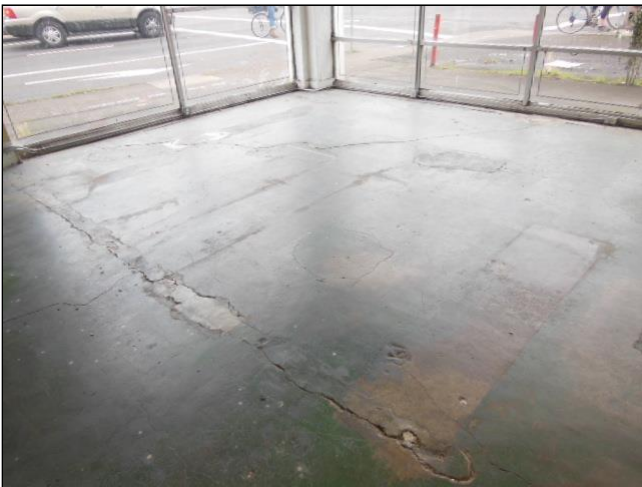
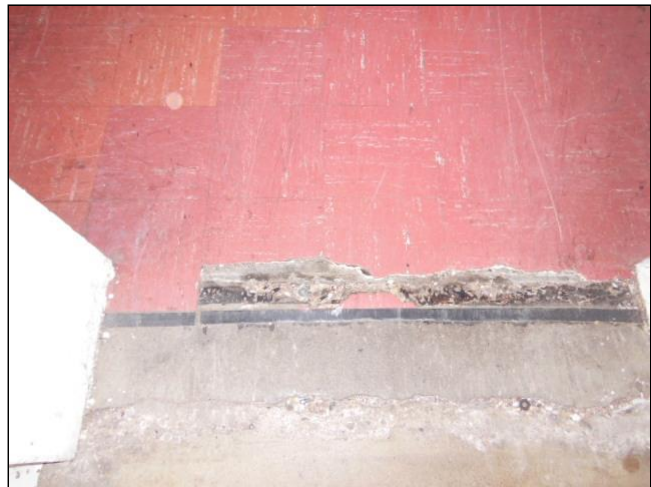
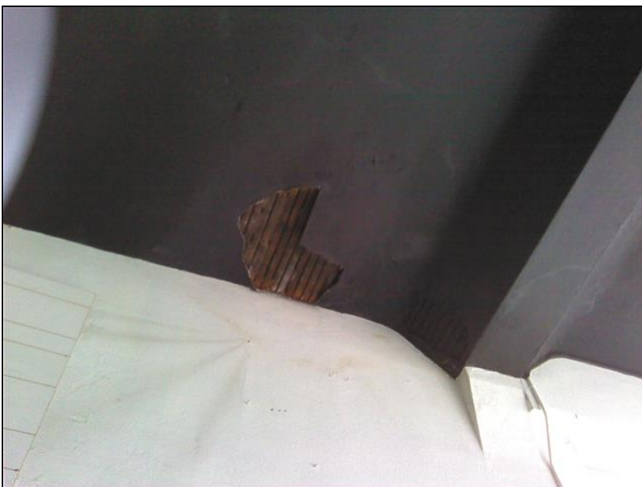
(1) partition walls in section 1 crudely put up some are not plumb. Most of the flooring is unfinished only the center section or section number 2 is finished and it has 9 inch adhesive tiles that may contain asbestos. There is cosmetic damage to lath and plaster in section 1 ceiling in the other sections have obvious leaks. Infrared scan at time of inspection did not show moisture. The existing stains may or may not precede existing roof covering. There may need to be some steel service to the roof. The obvious pronounced leakage from the ceiling of section #2 corresponds to patching on that roof. It is unknown how long but considered unlikely this patching will prove durable.

numerous holes in section 1 plaster.

estimate for plaster and wall repairs. Does not consider decorating.

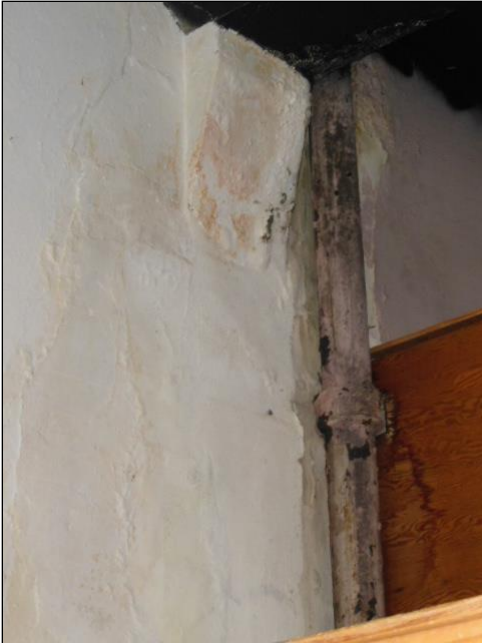
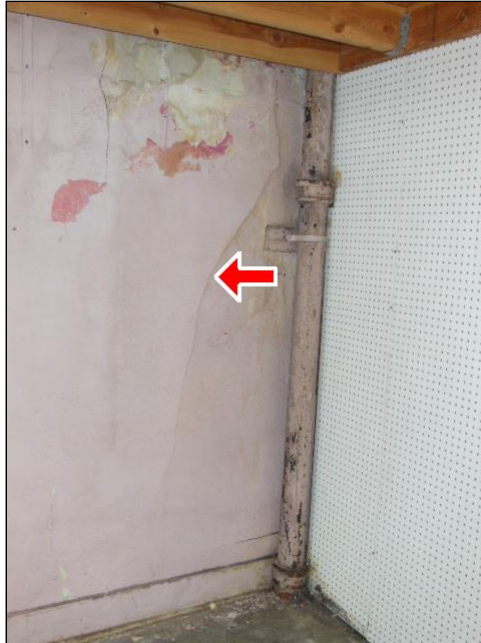
(2) In section 1, on the back South wall, near the west corner is a section of wall that has moisture damage. The masonry on the interior wall is damaged and bulging out. There was no moisture indicated at the time of inspection but the masonry should be repaired as in will likely fall of it's own accord in time and could be a hazard. This area of roof has limited drainage and there may be considerable water cascading down the exterior wall in this area during periods of heavy rain. It will be important to insure the drains are kept clear and free of debris.

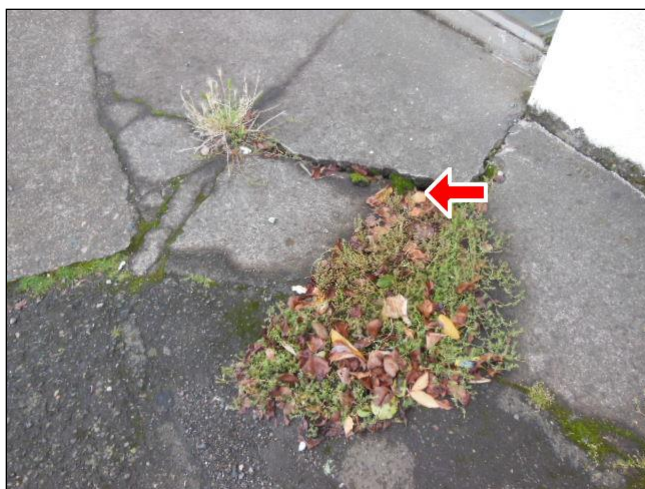
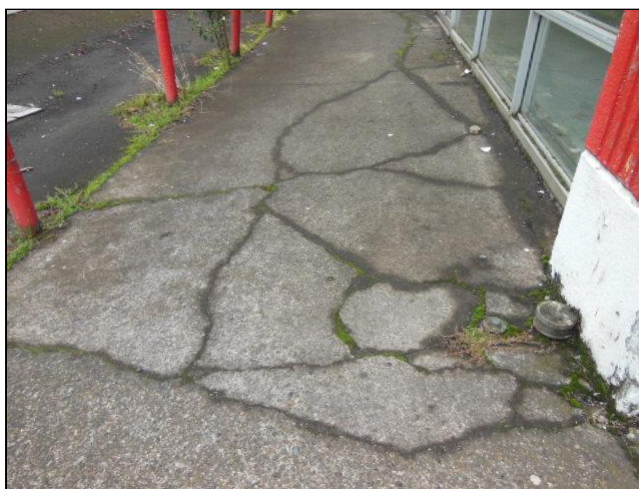
concrete walkway at front damaged, can be a trip hazard (near 82nd entrance)

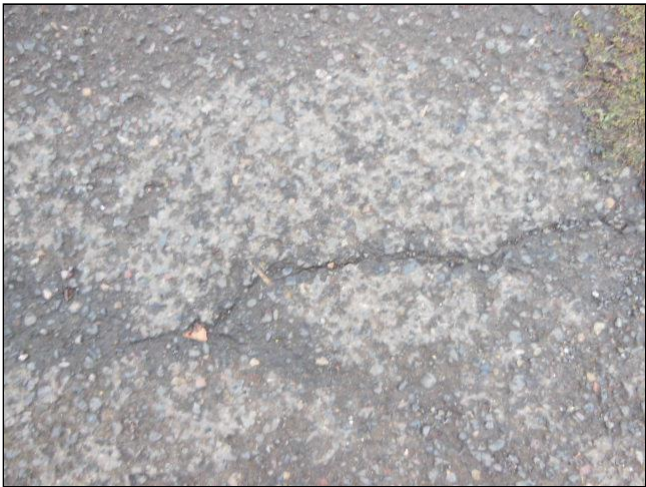
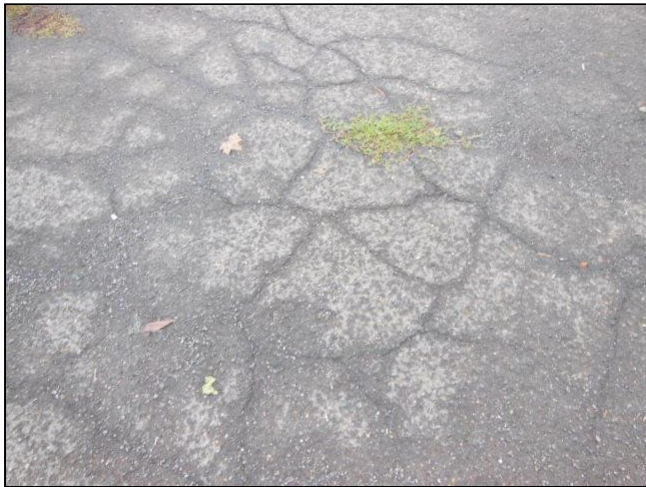
asphalt pavement overdue for patching and seal service.

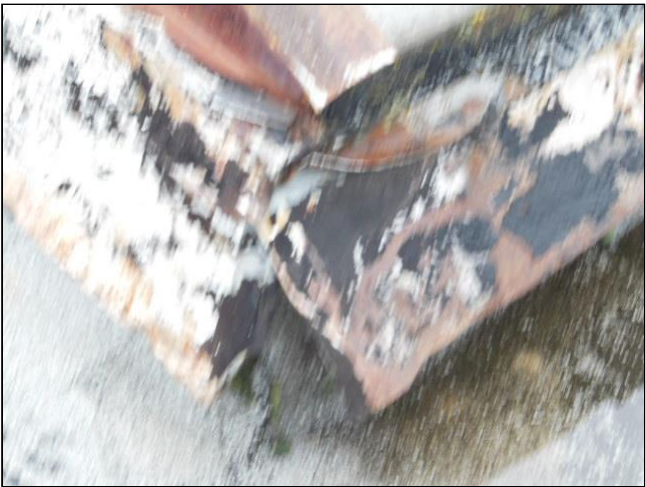
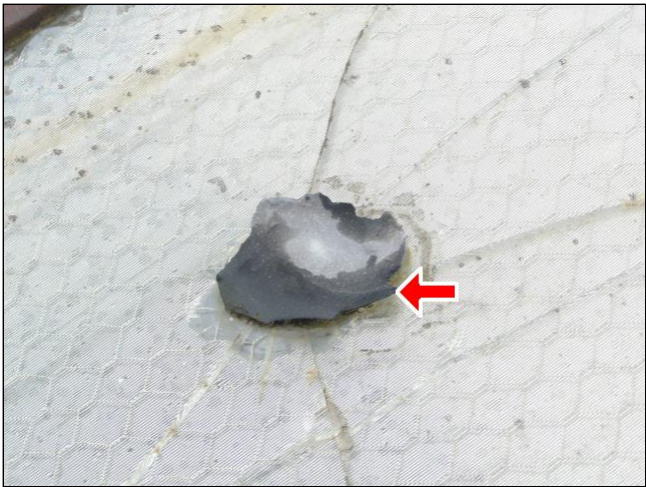
(1) skylight in roof section number 1 in poor condition, it has multiple sheet metal defects and broken glass. Some of the glass has been sealed with roofing materials. The skylight does not appear to be leaking at this time but will undoubtedly be a maintenance issue and need repair and seal service. You may wish to cover the skylight.

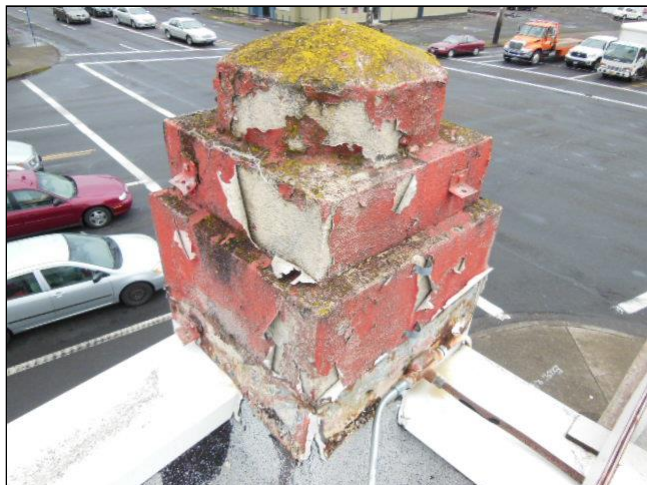
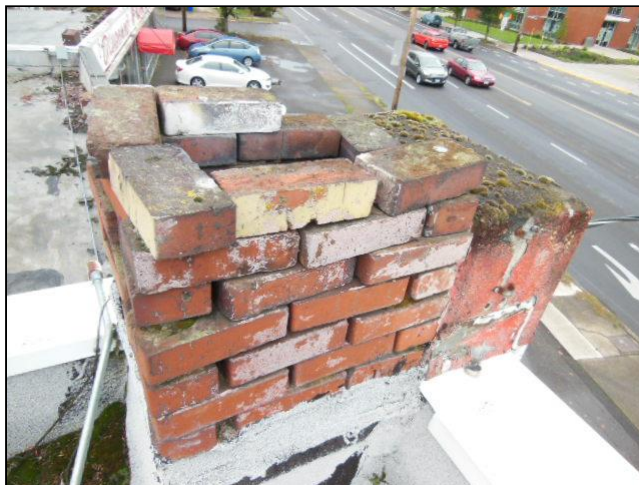
There are parapet protrusions at the roof section number 1 these are part of the stucco facade, part of the original section 1 of the structure. They all need service. NOTE: brick chimney at rear left corner (facing 82nd) is in poor condition and needs tuck point masonry service. This chimney is not in service and could be removed. (estimate is for chimney repair).

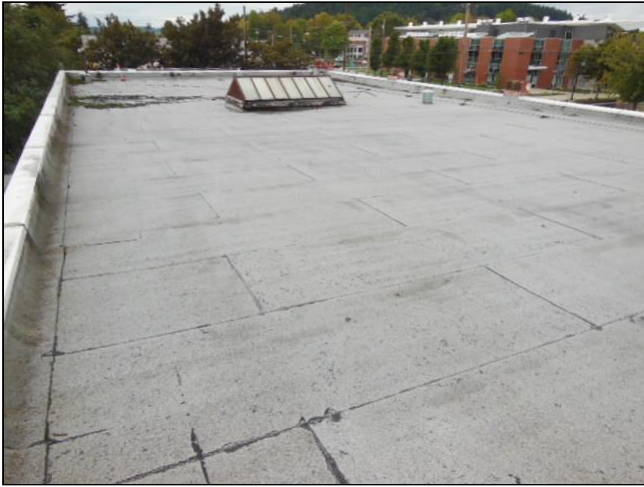
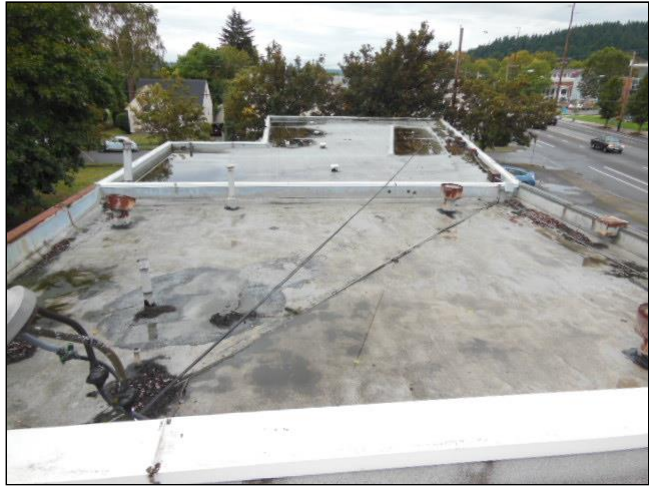
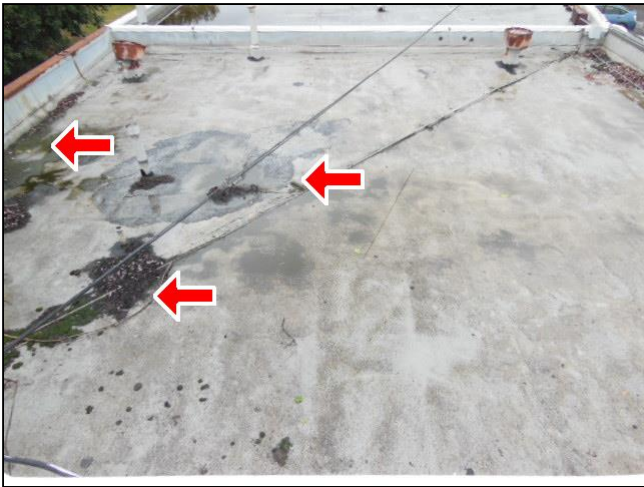
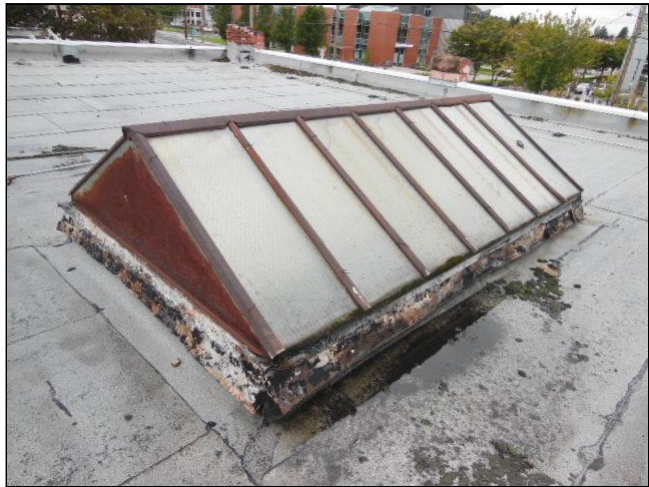
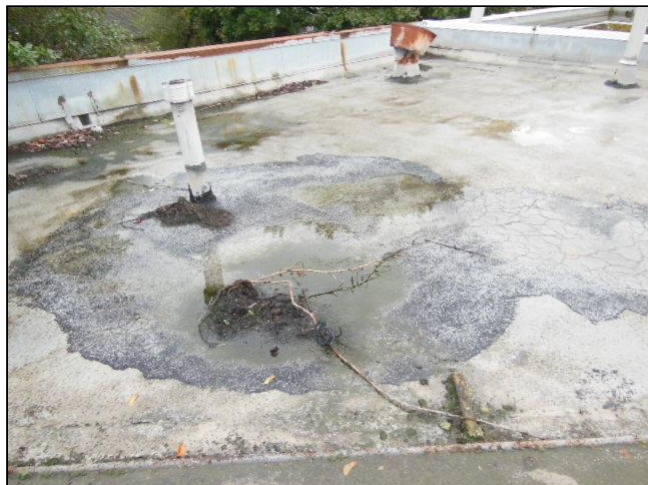
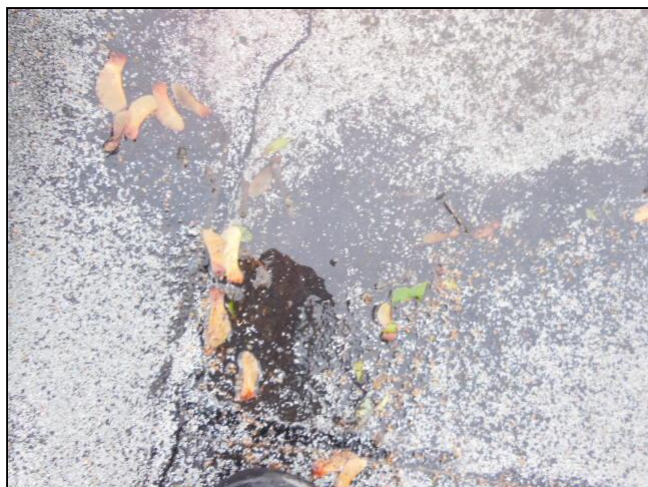
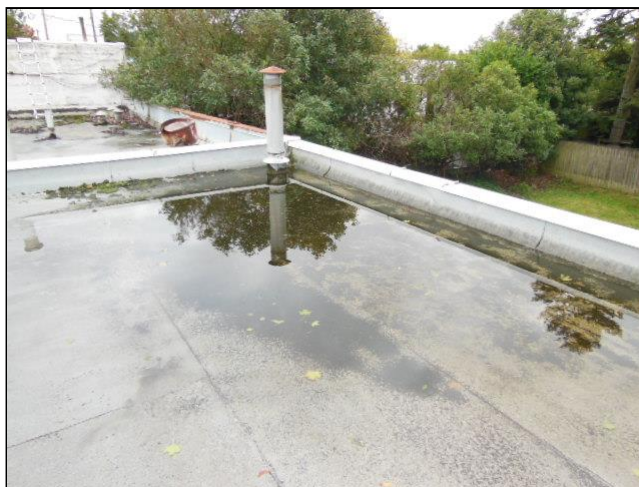
(1) There are effectively three roofs. Going west from southeast 82nd Street, section 1 roof is rolled composition or "torch down" roofing, roof number 2 was rolled composition roofing, with spray foam on top, and then roof number 3 which is rolled composition roofing similar to Roof #1. Roof #1 is currently in acceptable condition, needs minor cleaning and moss treatment. May need some minor seal service over time but should last another five years or more. Roof #2 has been sprayed over with foam roofing and has been patched several times (notable moisture stains corresponding to roof patches in interior) obviously have been some past leak issues. I can only recommend replacement of this roof area/ section. Roof #3 is in similar condition as roof number 1, however has several standing water areas that will probably need seal service more frequently.

estimate for replacement of middle section 2 and seal service to 1 & 2.

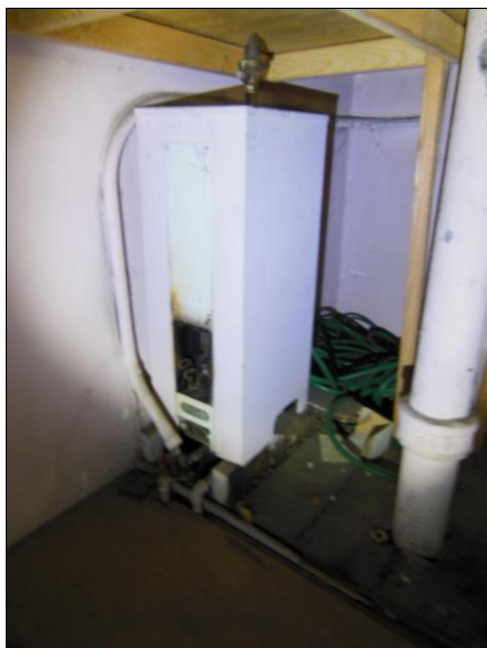
C. Item 1(Picture)

very old small on demand electric boiler system located in the mezzanine exposed wiring improper safety valve discharge do not recommend operation. Recommend replacement.

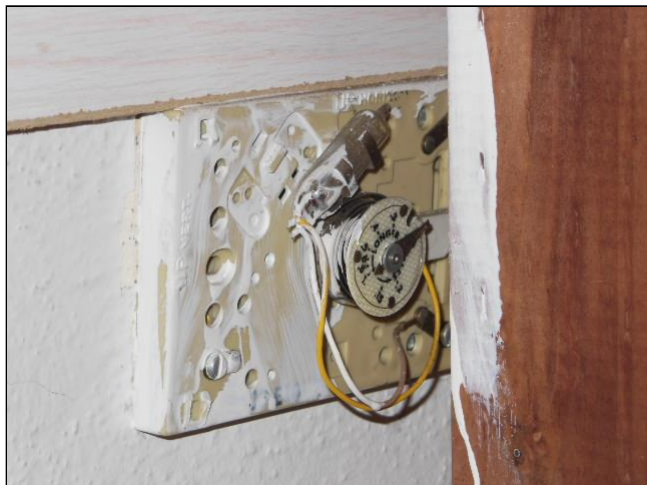
D. Item 1(Picture)

Each of the three sections are heated by an individual space heater. These units are very simple and easily repaired. However, they are more typically used in open service or warehouse areas, not areas that are occupied by personnel. The thermostat for space heater in section number 1 damaged, section 2 unresponsive; recommend replacement/service.

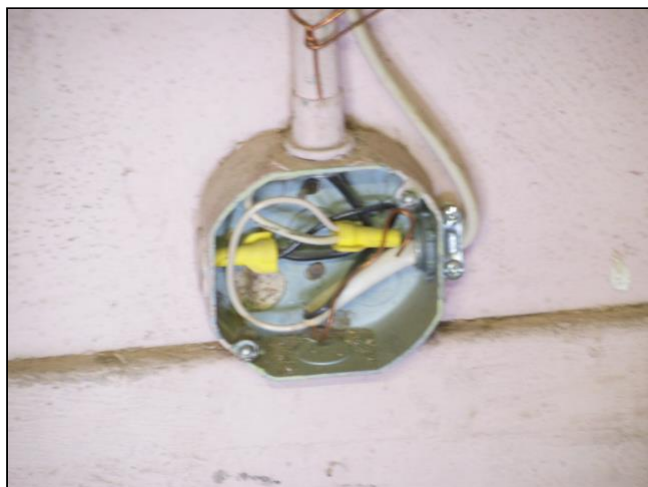
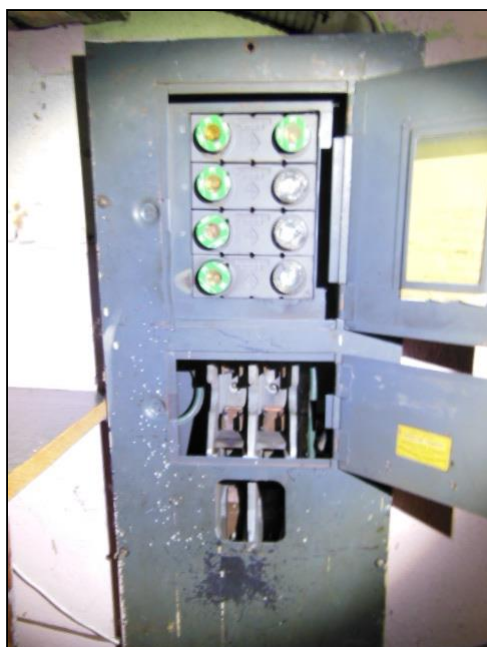
(1) Section 1 of the building served by an old fuse panel manufacturer by Coast electric. This is main is missing the main fuses so some of this is not energized. However some is connected through an old Federal Pacific sub panel and the rest of the wiring in that section is controlled by a series of older MCC station disconnects.

Section 3 is served by a 200 amp Federal Pacific electrical panel. Some of the circuits on this panel are decommissioned and appear to not properly be terminated as the panel is marked not to energize those branch circuits. The Bulldog pushmatic and Federal Pacific panels should be replaced. See additional comments about this equipment. There are a few improperly terminated branch circuits and uncovered junction boxes. The electrical distribution system should be evaluated and repaired by a qualified electrician.

(3) The main electrical panel was manufactured by Federal Pacific Electric Company and employs Stablok breakers and other components that have been alleged to be defective. However, the panel is old and the company is now out of business. There is considerable information about these panel on the internet, most of it not good news. You should look it up yourself and make your own decision how to proceed with the advice of a reputable licensed electrician. Our best advice is that the panel(s) be replaced.
