# Inspection Report

## Oregon Metro

**Property Address:**  
2517 SE 82nd Ave.  
Portland OR

<b>Date:</b> 10/17/2014	<b>Time:</b> 10:04 AM	<b>Report ID:</b> 20141017a
<b>Property:</b> 2517 SE 82nd Ave. Portland OR	<b>Customer:</b> Oregon Metro	<b>Real Estate Professional:</b>

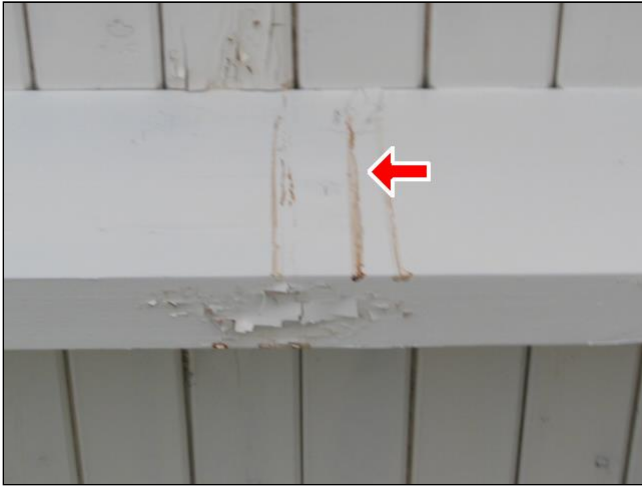
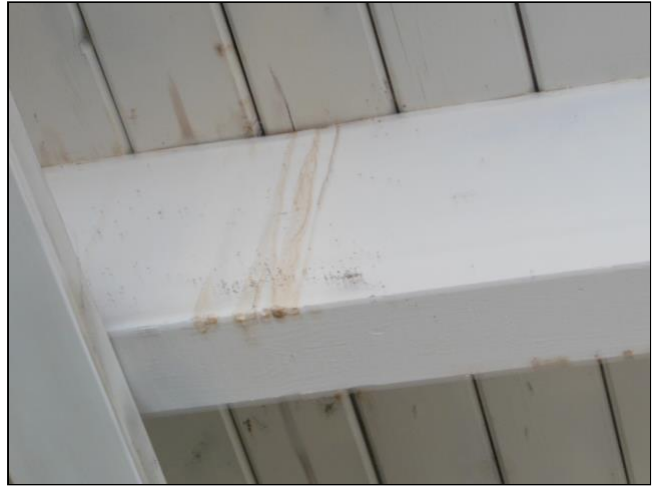
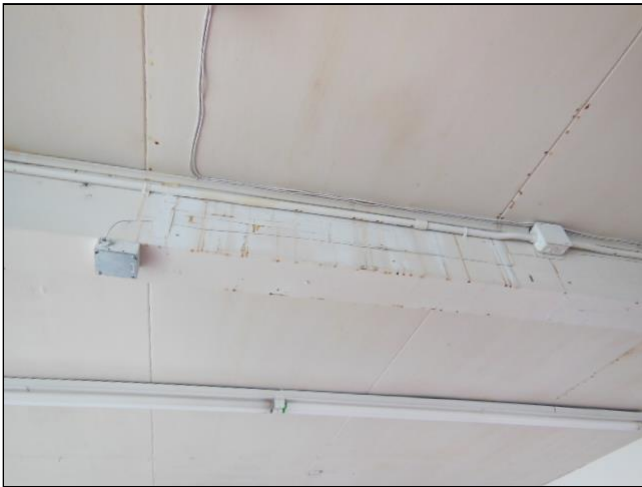
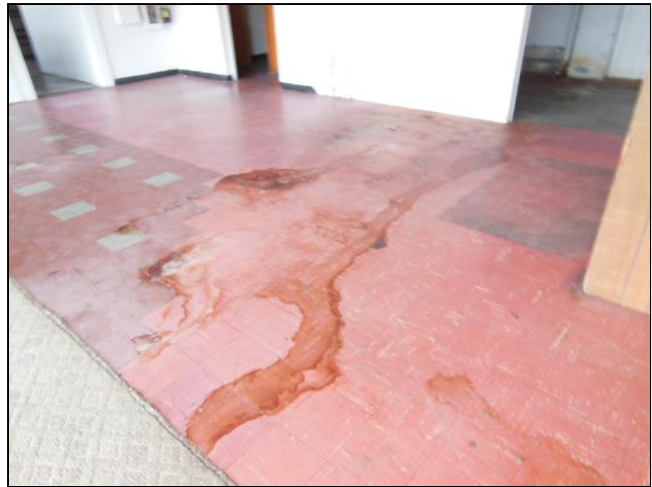
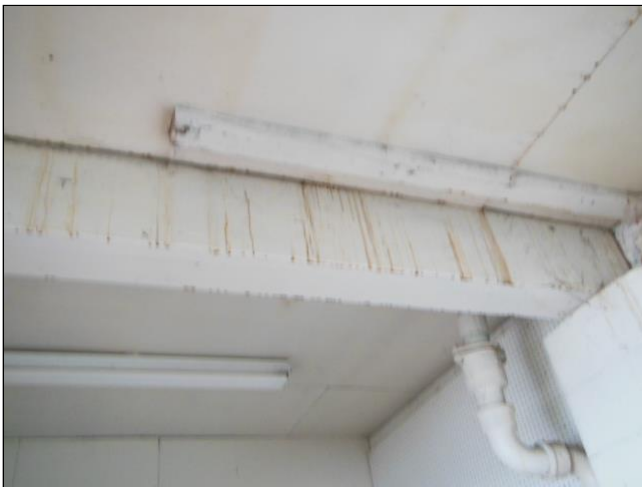
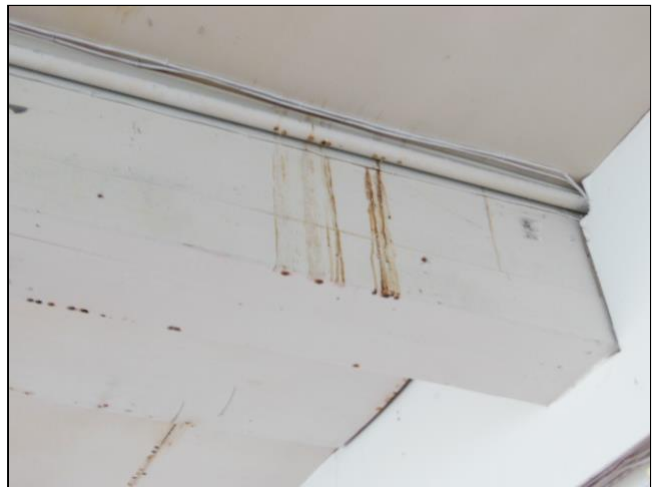
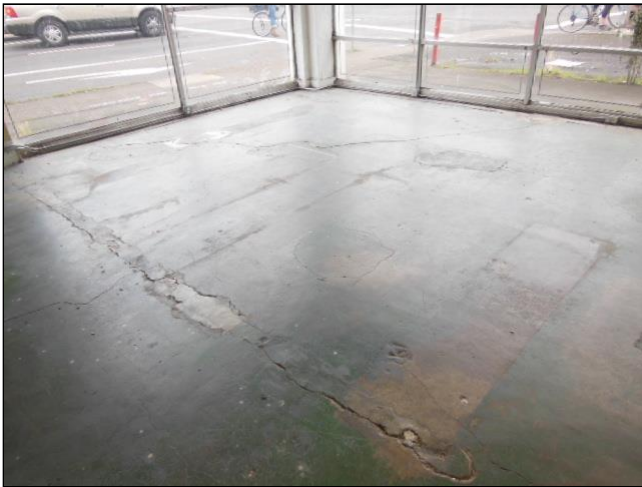
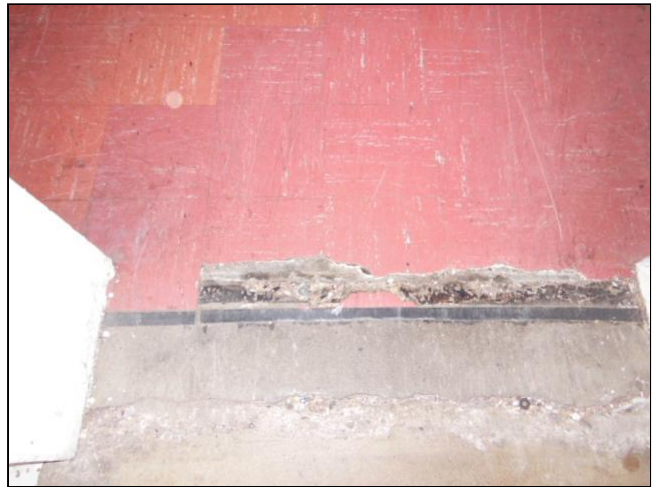
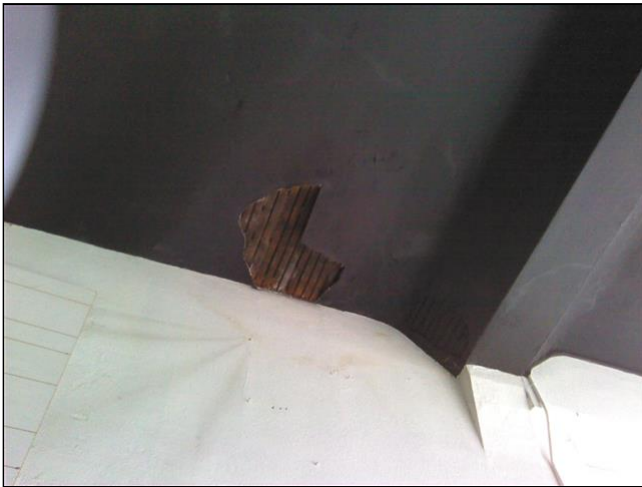
(1) partition walls in section 1 crudely put up some are not plumb. Most of the flooring is unfinished only the center section or section number 2 is finished and it has 9 inch adhesive tiles that may contain asbestos. There is cosmetic damage to lath and plaster in section 1 ceiling in the other sections have obvious leaks. Infrared scan at time of inspection did not show moisture. The existing stains may or may not precede existing roof covering. There may need to be some steel service to the roof. The obvious pronounced leakage from the ceiling of section #2 corresponds to patching on that roof. It is unknown how long but considered unlikely this patching will prove durable.

estimate for plaster and wall repairs. Does not consider decorating.
