A PHASE I ENVIRONMENTAL SITE ASSESSMENT

0.69-Acre Commercial Property
2517 SE 82nd Avenue, Portland, Oregon
Multnomah Co. Tax Lots IS2E05DD-00800 and 00900

November 14, 2014

Prepared for:
Metro
Portland, Oregon

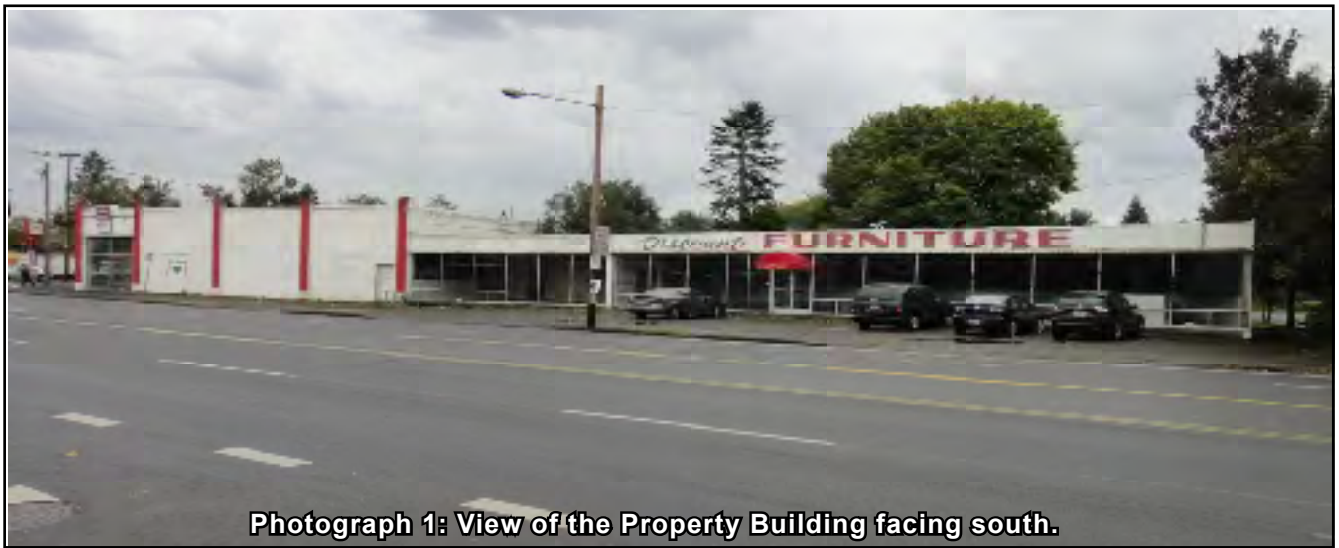
Photograph 1: View of the Property Building facing south.

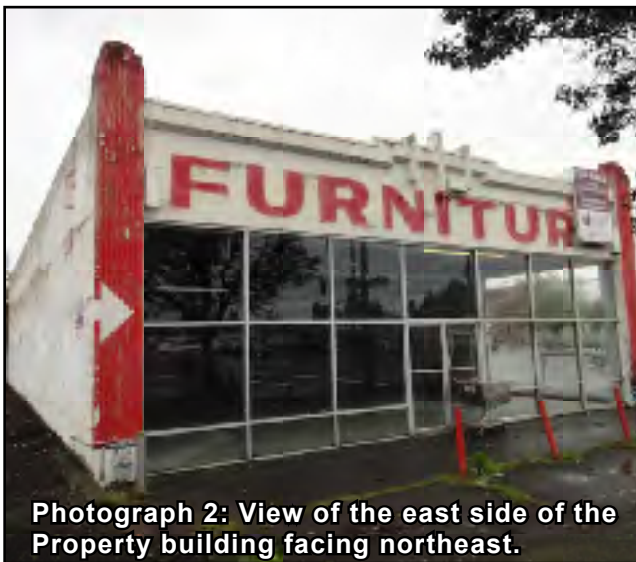
Photograph 2: View of the east side of the Property building facing northeast.

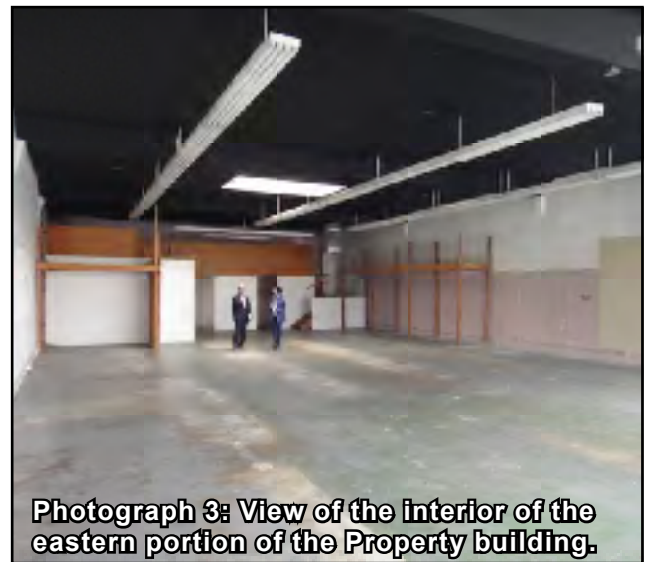
Photograph 3: View of the interior of the eastern portion of the Property building.

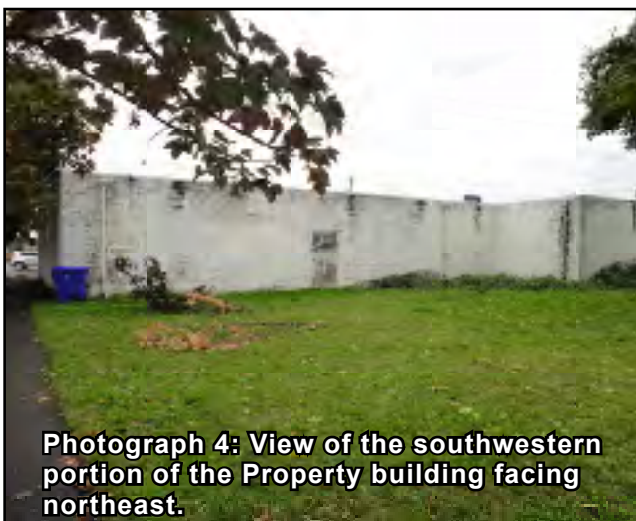
Photograph 4: View of the southwestern portion of the Property building facing northeast.

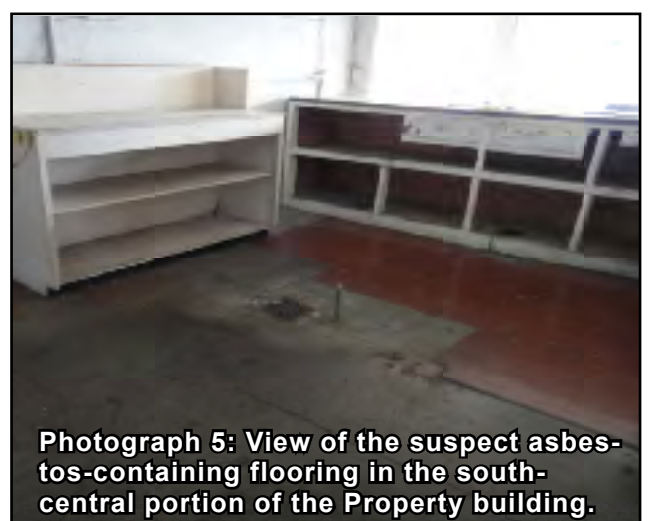
2. **FINDING:** AAI conducted a cursory, visual inspection for suspect ACMs at the Property. Suspect ACMs included red vinyl floor tiles in the showroom, sales area and restroom in the central portion of the Property building, along with areas of plaster and wallboard on the walls.
OPINION: Based on the age of the building, those materials may contain asbestos.
BEST MANAGEMENT PRACTICES RECOMMENDATION: An asbestos survey should be conducted prior to conducting any renovation or demolition at the Property, and any identified ACMs should be abated or properly managed in place.

Photograph 5: View of the suspect asbestos-containing flooring in the south-central portion of the Property building.

BEST MANAGEMENT PRACTICES RECOMMENDATION: An asbestos survey should be conducted prior to conducting any renovation or demolition at the Property, and any identified ACMs should be abated or properly managed in place.
