# A PHASE I ENVIRONMENTAL SITE ASSESSMENT

4.36-Acre Property Vicinity of NW Civic Street and NW 13th Avenue Gresham, Oregon

July 12, 2001

Hahn and Associates, Inc. Portland, Oregon

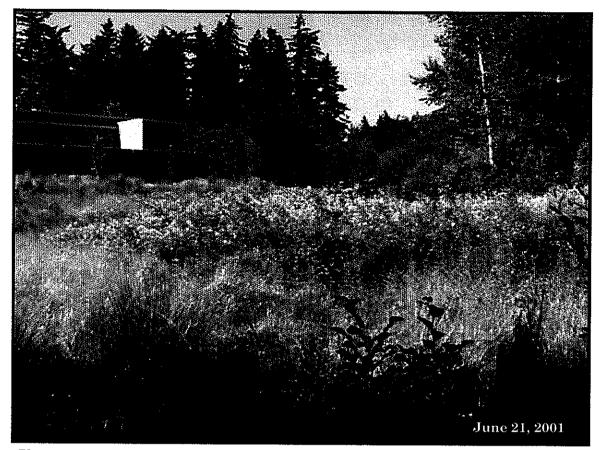
Photograph 1. View of the grassy southeastern portion of the subject property facing southwest.

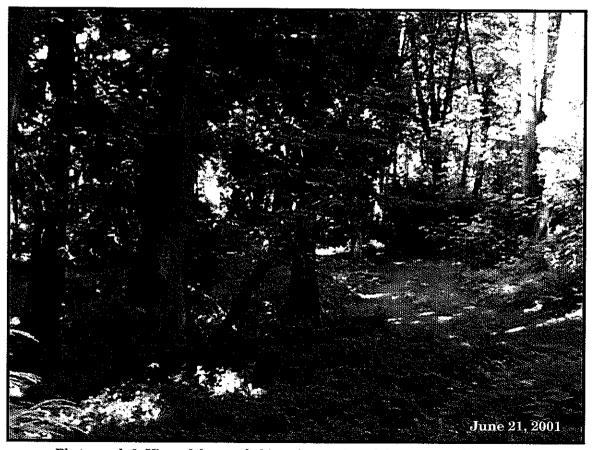
Photograph 2. View of the wooded interior portion of the property facing south.
