**Re: Addendum to Phase I Environmental Site Assessment  
Supplemental Site Reconnaissance – Elmonica Opportunity Site  
Beaverton, Oregon  
Project No. 1346009.010.011**

**Supplemental Site Reconnaissance**

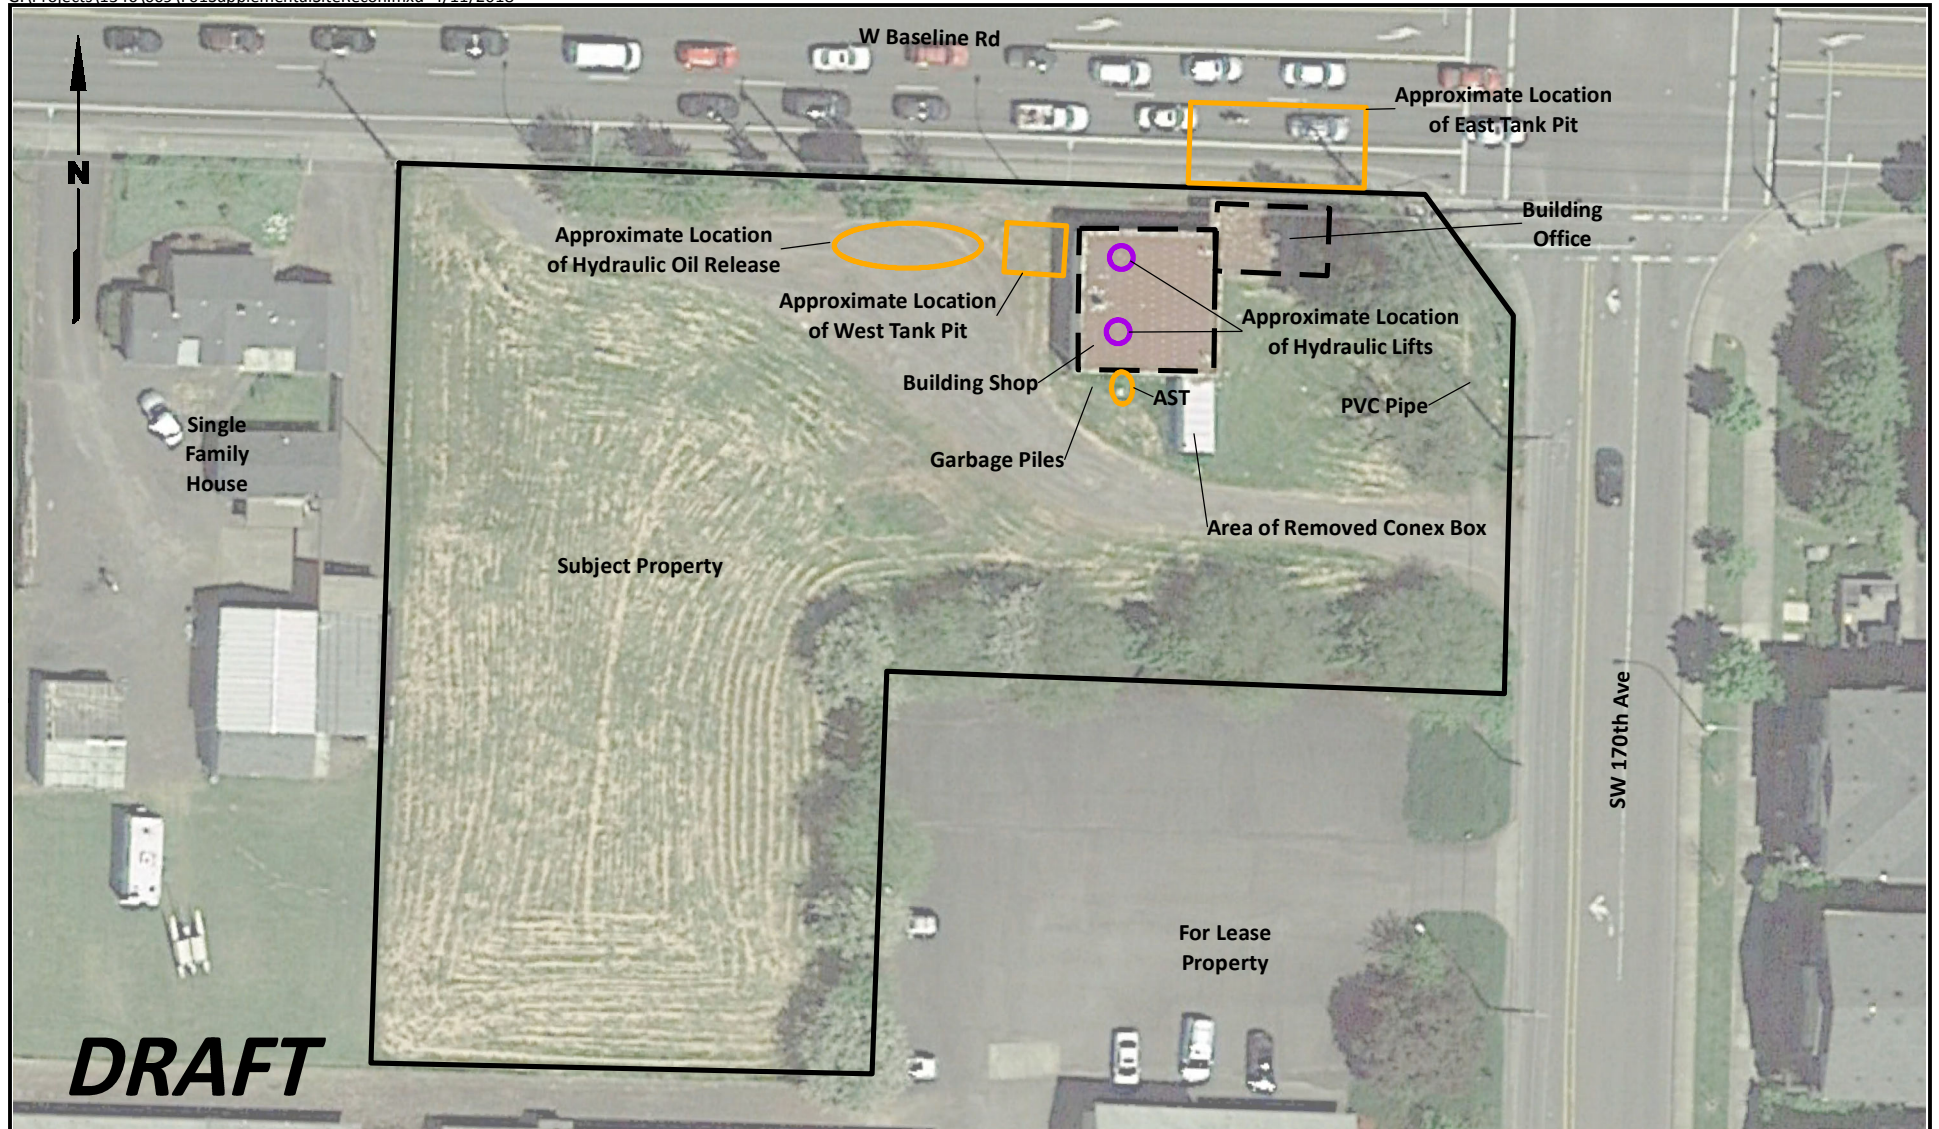
Figure  
**1**

- Two in-ground hydraulic lifts are located in the building near the garage doors. There is the potential for localized soil contamination to be present in the vicinity of the hydraulic lifts. Hydraulic oil has the potential to contain polychlorinated biphenyls (PCBs).

The hydraulic lifts were not investigated during the Phase II subsurface investigation (2018b). Removal of the lifts and impacted soil, if encountered, is recommended. Soil sampling is recommended following removal of the lifts to document soil conditions in the vicinity of the lifts.

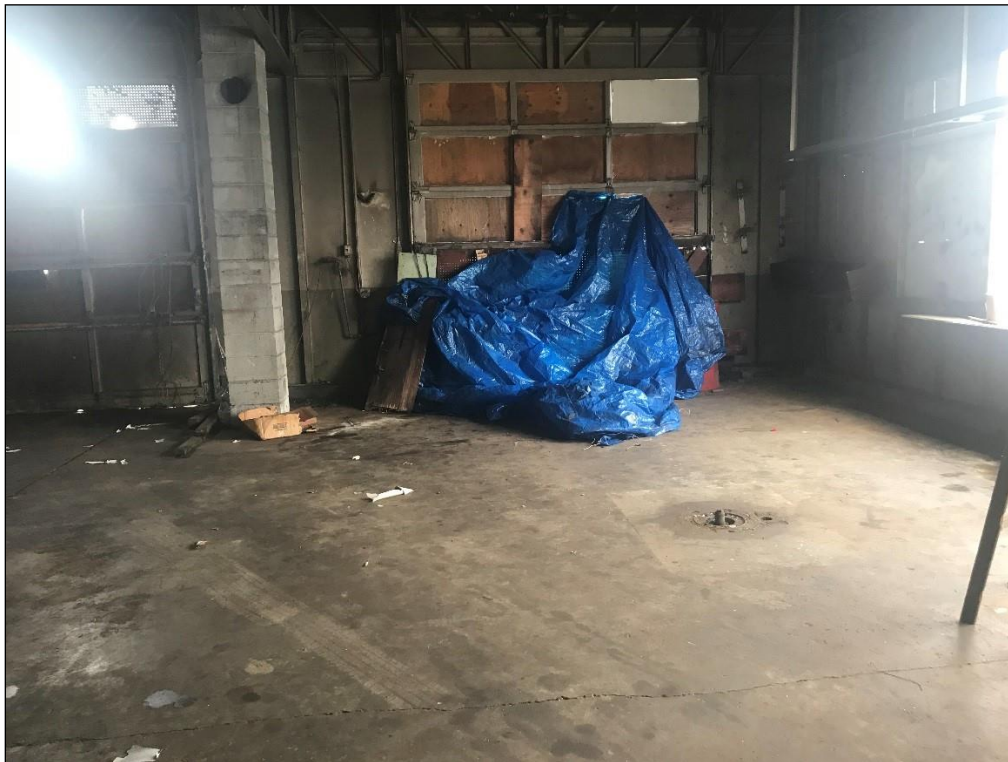
1. Hydraulic lift associated with the northwest garage door. Tarp is covering the work bench and hole in the garage door.

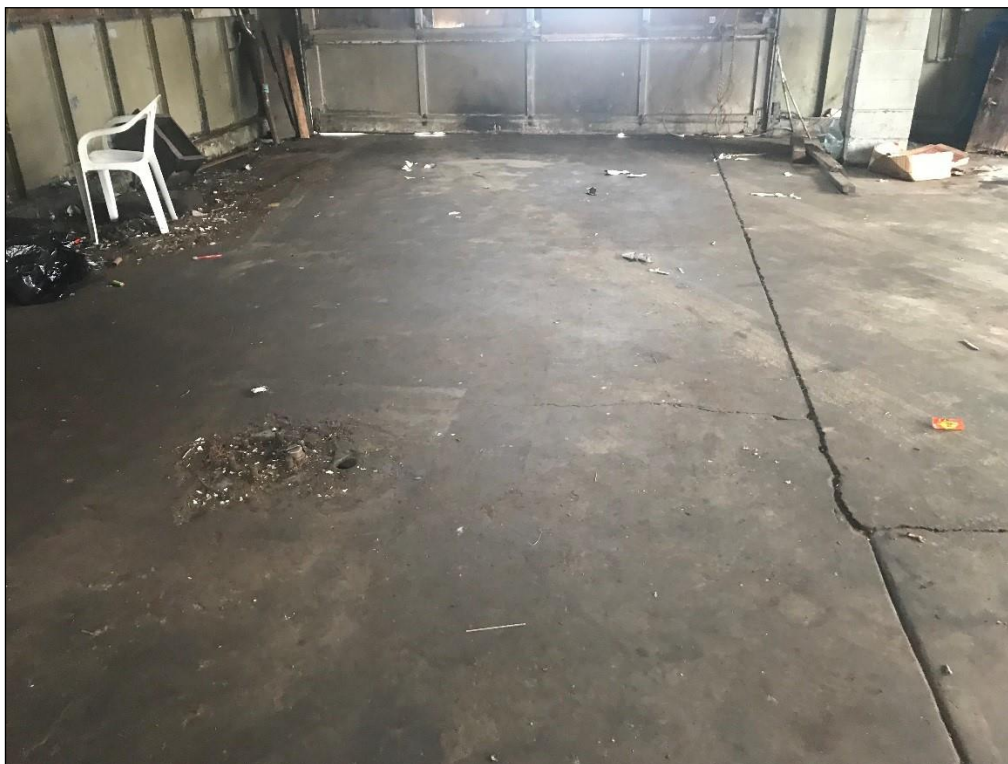
2. Second hydraulic lift associated with the southwest garage door.

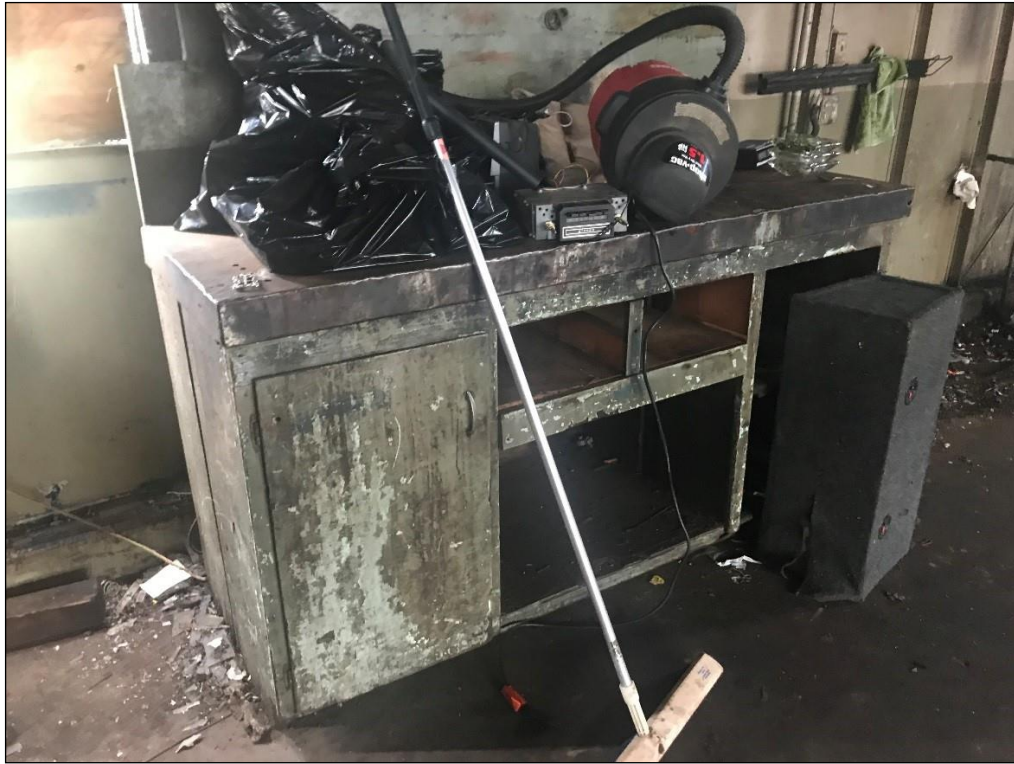
3. Work bench, debris, and sweepings along south wall of the subject property building.

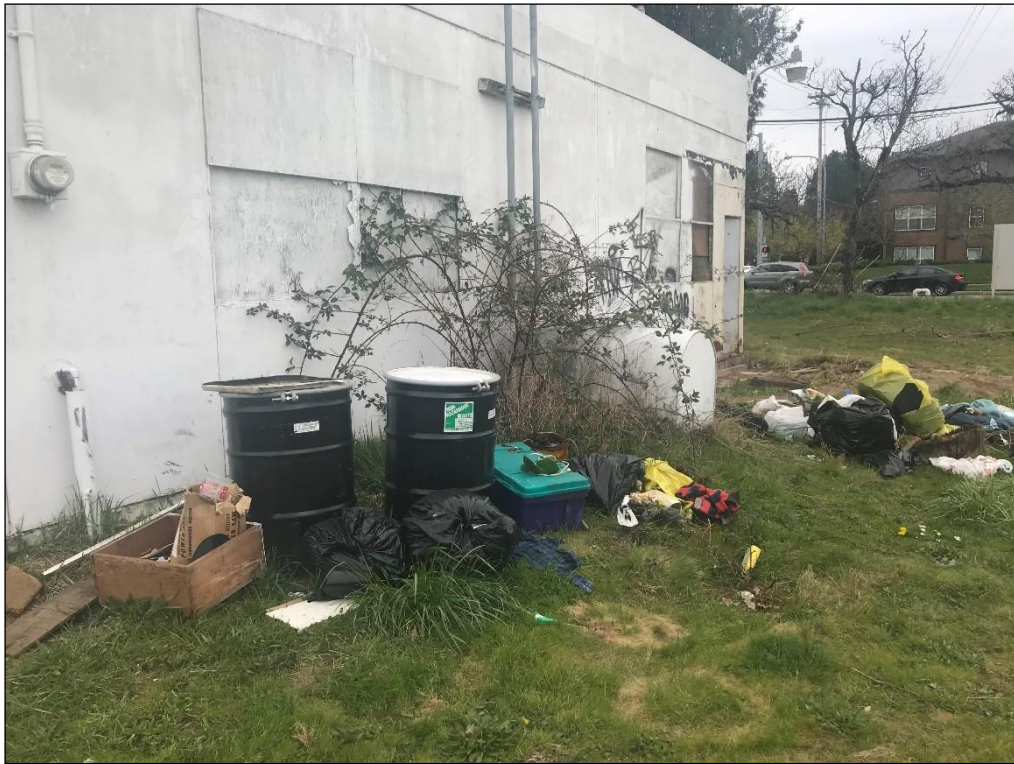
- Piles of garbage were noted outside the building. The garbage appears to be associated with illegal dumping and has increased in volume since the time of the original site reconnaissance.
- The Conex box previously located on the southeast side of the station building was no longer present.
- A large pile of tires was noted near the northwest garage door. The tires appear to be blocking a hole in the bottom of the garage door.

4. Piles of debris located on the south side of the building.
