**Draft Phase I Environmental Site Assessment
Elmonica Opportunity Site
17030 SW Baseline Road
Beaverton, Oregon**

February 23, 2018

Prepared for

Office of Metro Attorney
600 NE Grand Avenue
Portland, Oregon

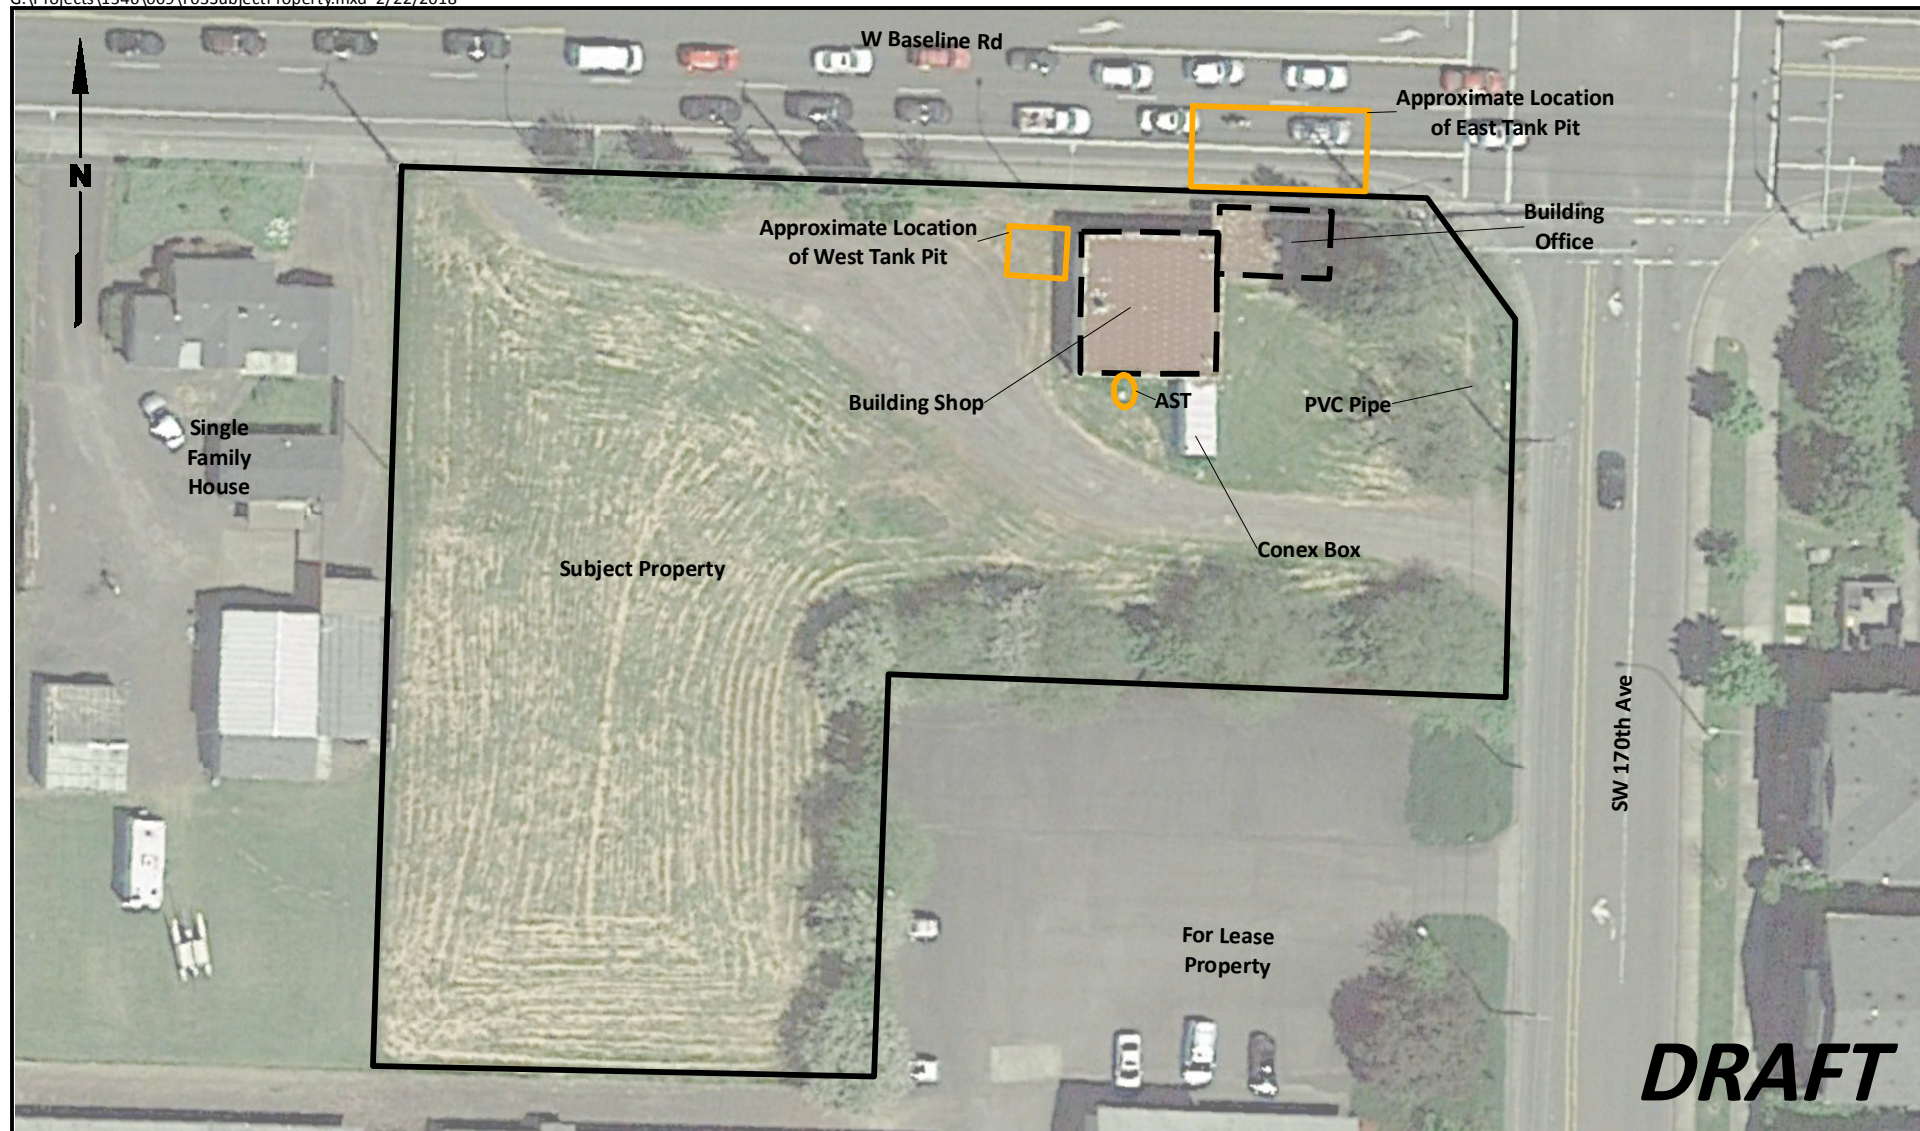
- Subject Property
- Approximate Tank Locations

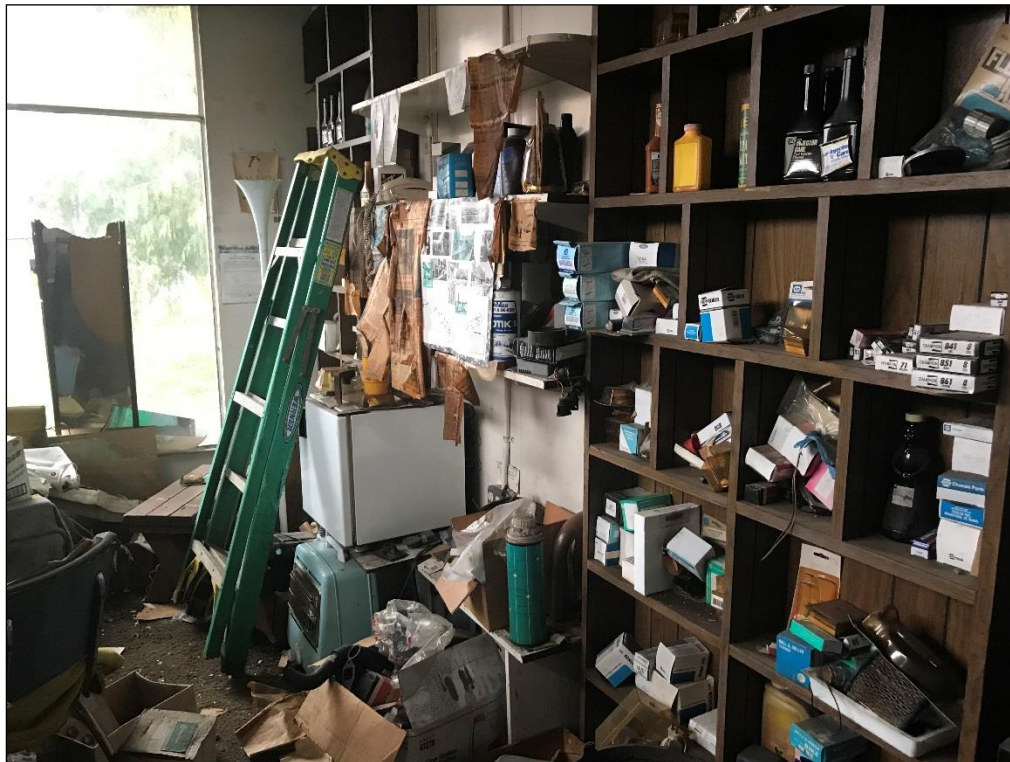
Issue	Comments
Hazardous materials or petroleum products:	Multiple containers of motor oil, lubricants, petroleum products, and waste products were observed in the building (Appendix A, Photos 1 and 2).
Hazardous waste:	Drums of waste oil/lubricants and solvent waste were present in the interior of the building (Photo 3).
Solid waste:	The interior of the building was covered with old material, glass, broken items, and trash (Photo 4). Multiple piles of garbage were noted along the boundaries of the subject property.
Wells:	None observed. A 6-inch polyvinyl chloride pipe was noted on the east side of the subject property, but did not appear to be associated with a well (Photo 5). Mrs. Setniker indicated that a well is located on the subject property; however, the location of the well was not verified at the time of the site reconnaissance.
Wastewater:	None observed.

1. Interior of office, looking east.

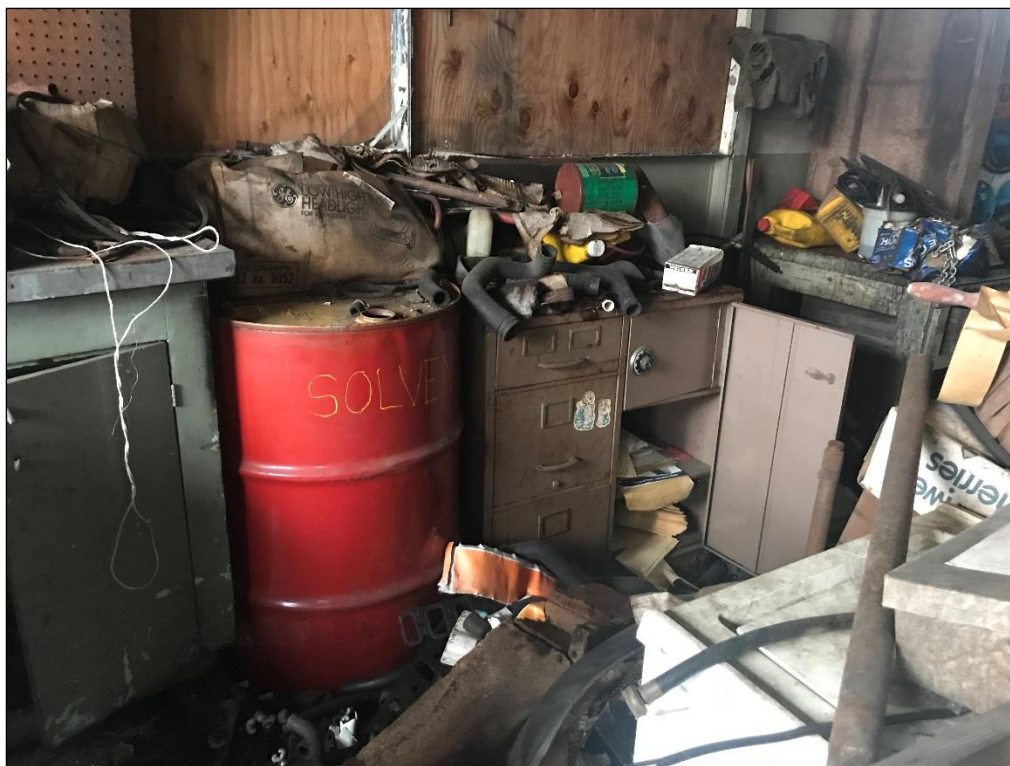
2. Interior of shop, looking east.

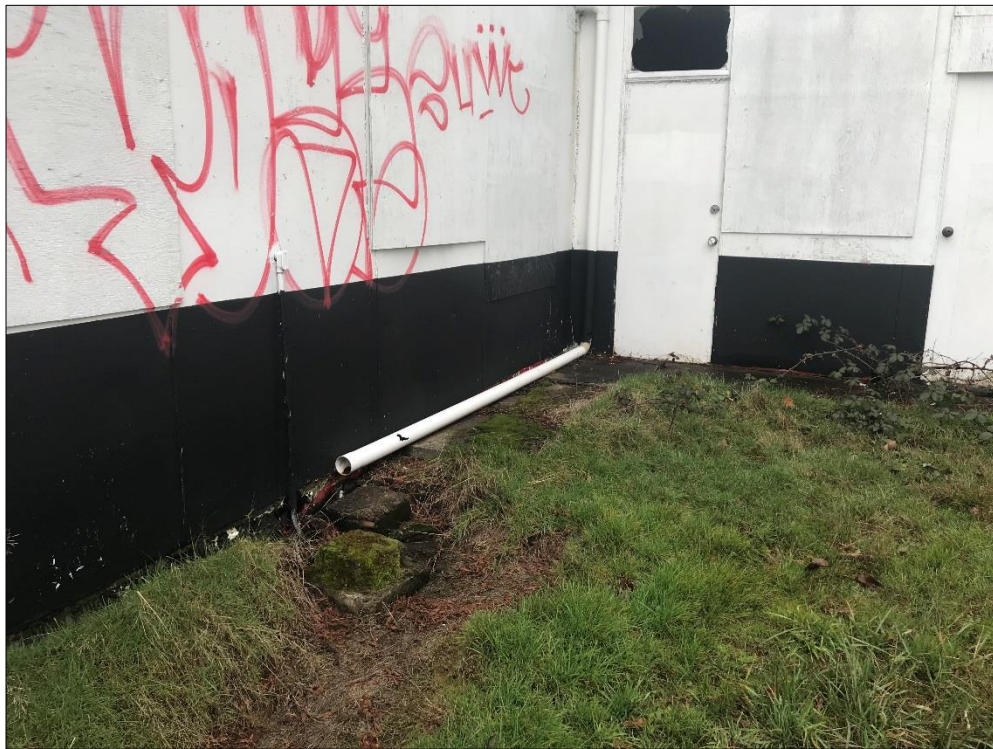
8. Looking northwest at the downspout.

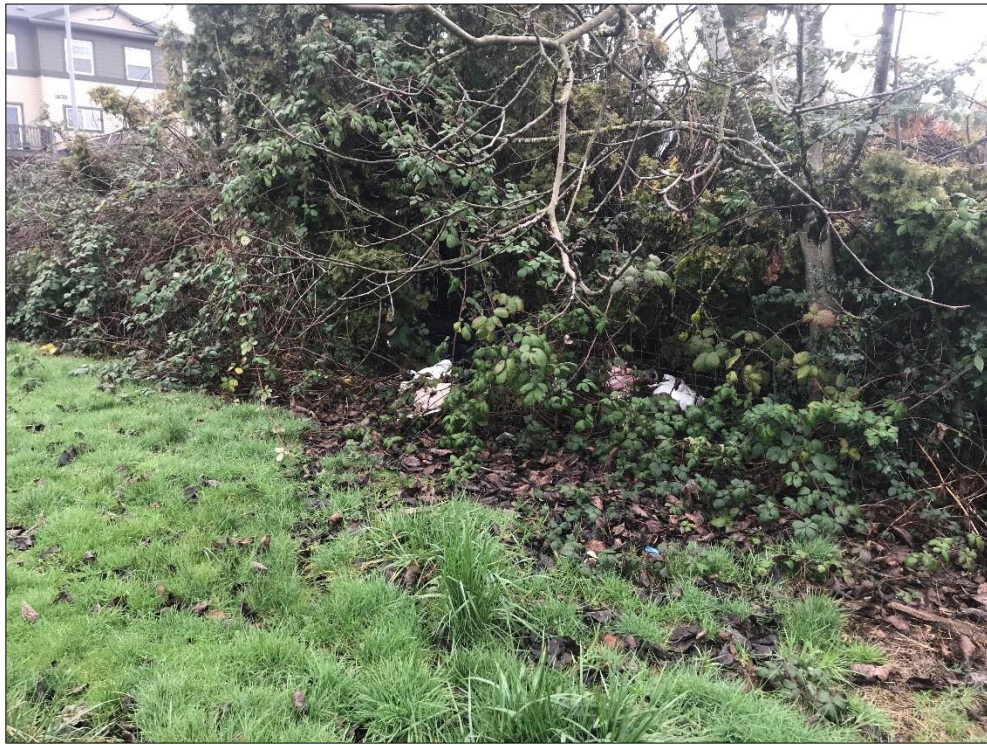
9. View of garbage on southeast fence line.

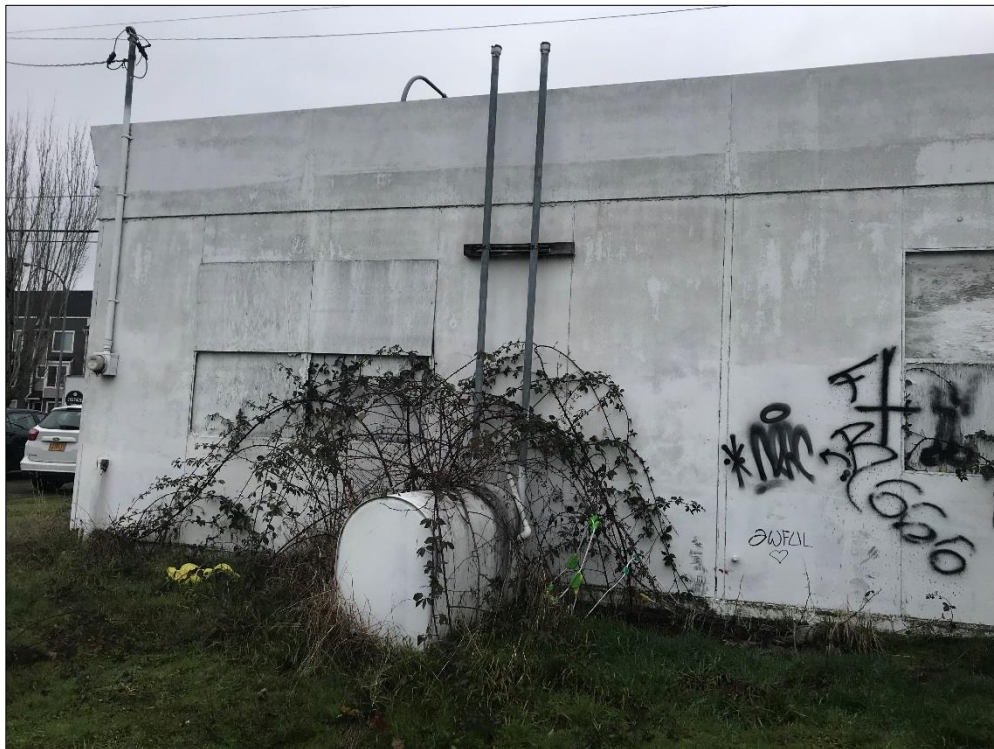
Evidence of former USTs was noted on the south side of the building. Two vent pipes were observed next to an AST. The pipes did not appear to be connected to the AST, but used for venting of the USTs (Photo 10). The empty AST remaining on the south side of the subject property building had a capacity of approximately 50 gallons. The AST appeared to connect to the interior of the subject property building via a disconnected metal pipe (Photo 11). The AST smelled of gasoline, and the interior pipe appears to have been used to dispose of waste oil inside the subject property building. The AST did not appear to be damaged, and no evidence of a release was noted. The AST did not appear to be equipped with secondary containment and is considered a potential environmental concern.

10. Looking north at the aboveground storage tank (AST).

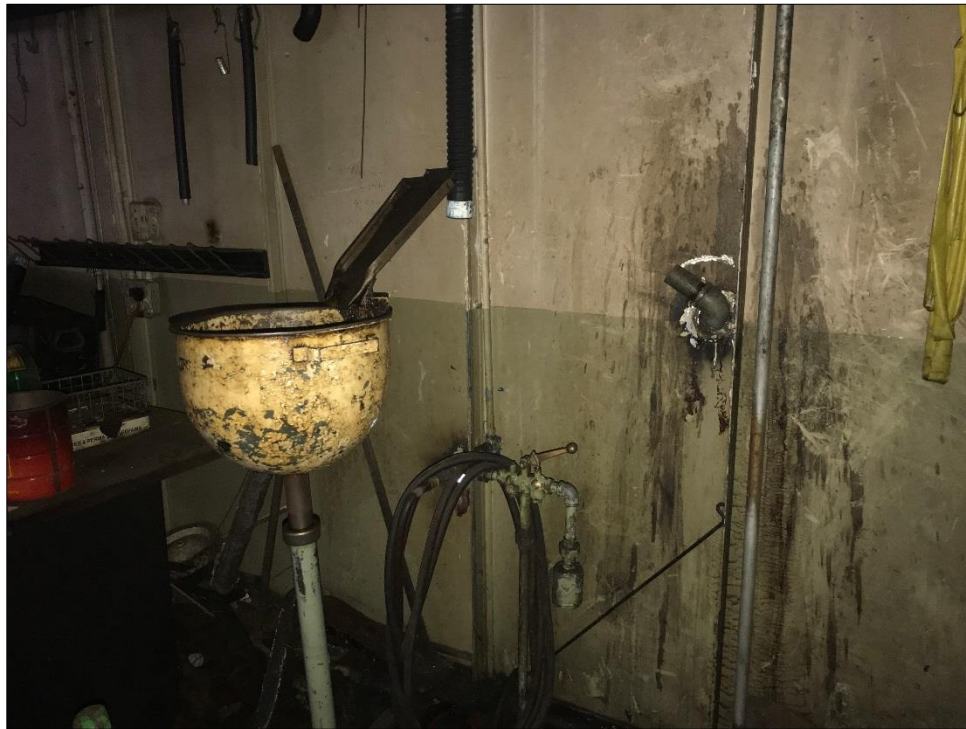
11. Looking southeast at the interior pipe for the AST.
