## Limited Environmental Investigation Report

0.69-Acre Commercial Property  
2517 SE 82nd Avenue, Portland, Oregon  
Multnomah Co. Tax Lots IS2E05DD-00800 and 00900

Prepared for:  
Metro  
Portland, Oregon

AAI Project No. 1408

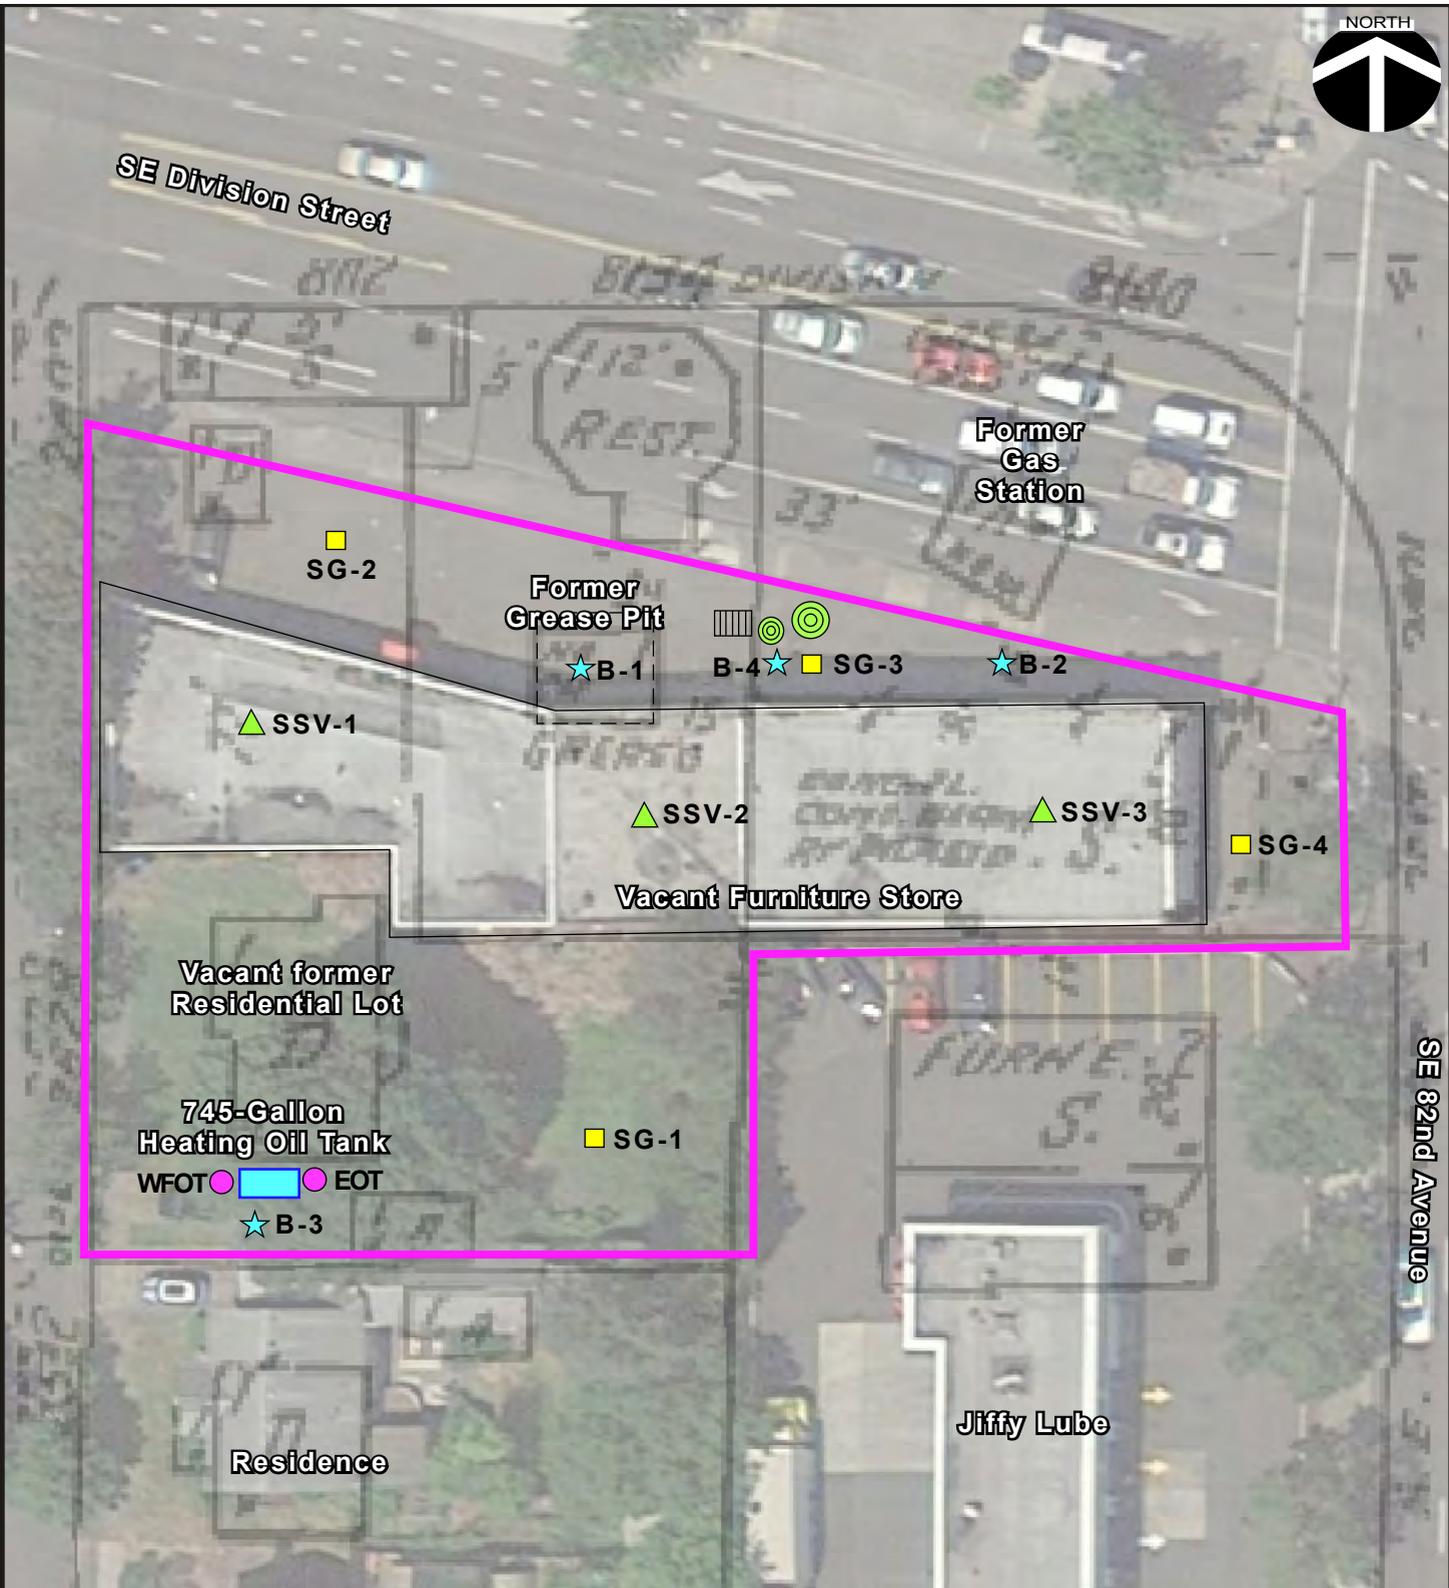
Figure 2 – Site Features and Sample Locations

Site features and sample locations are illustrated on Figure 2. Soil boring logs and vapor sampling field notes are presented in Appendix A. Copies of the geophysical survey report and the HOT assessment report are included in Appendix B and C, respectively. Standard operating procedures for the specified logging and sampling tasks are available upon request.

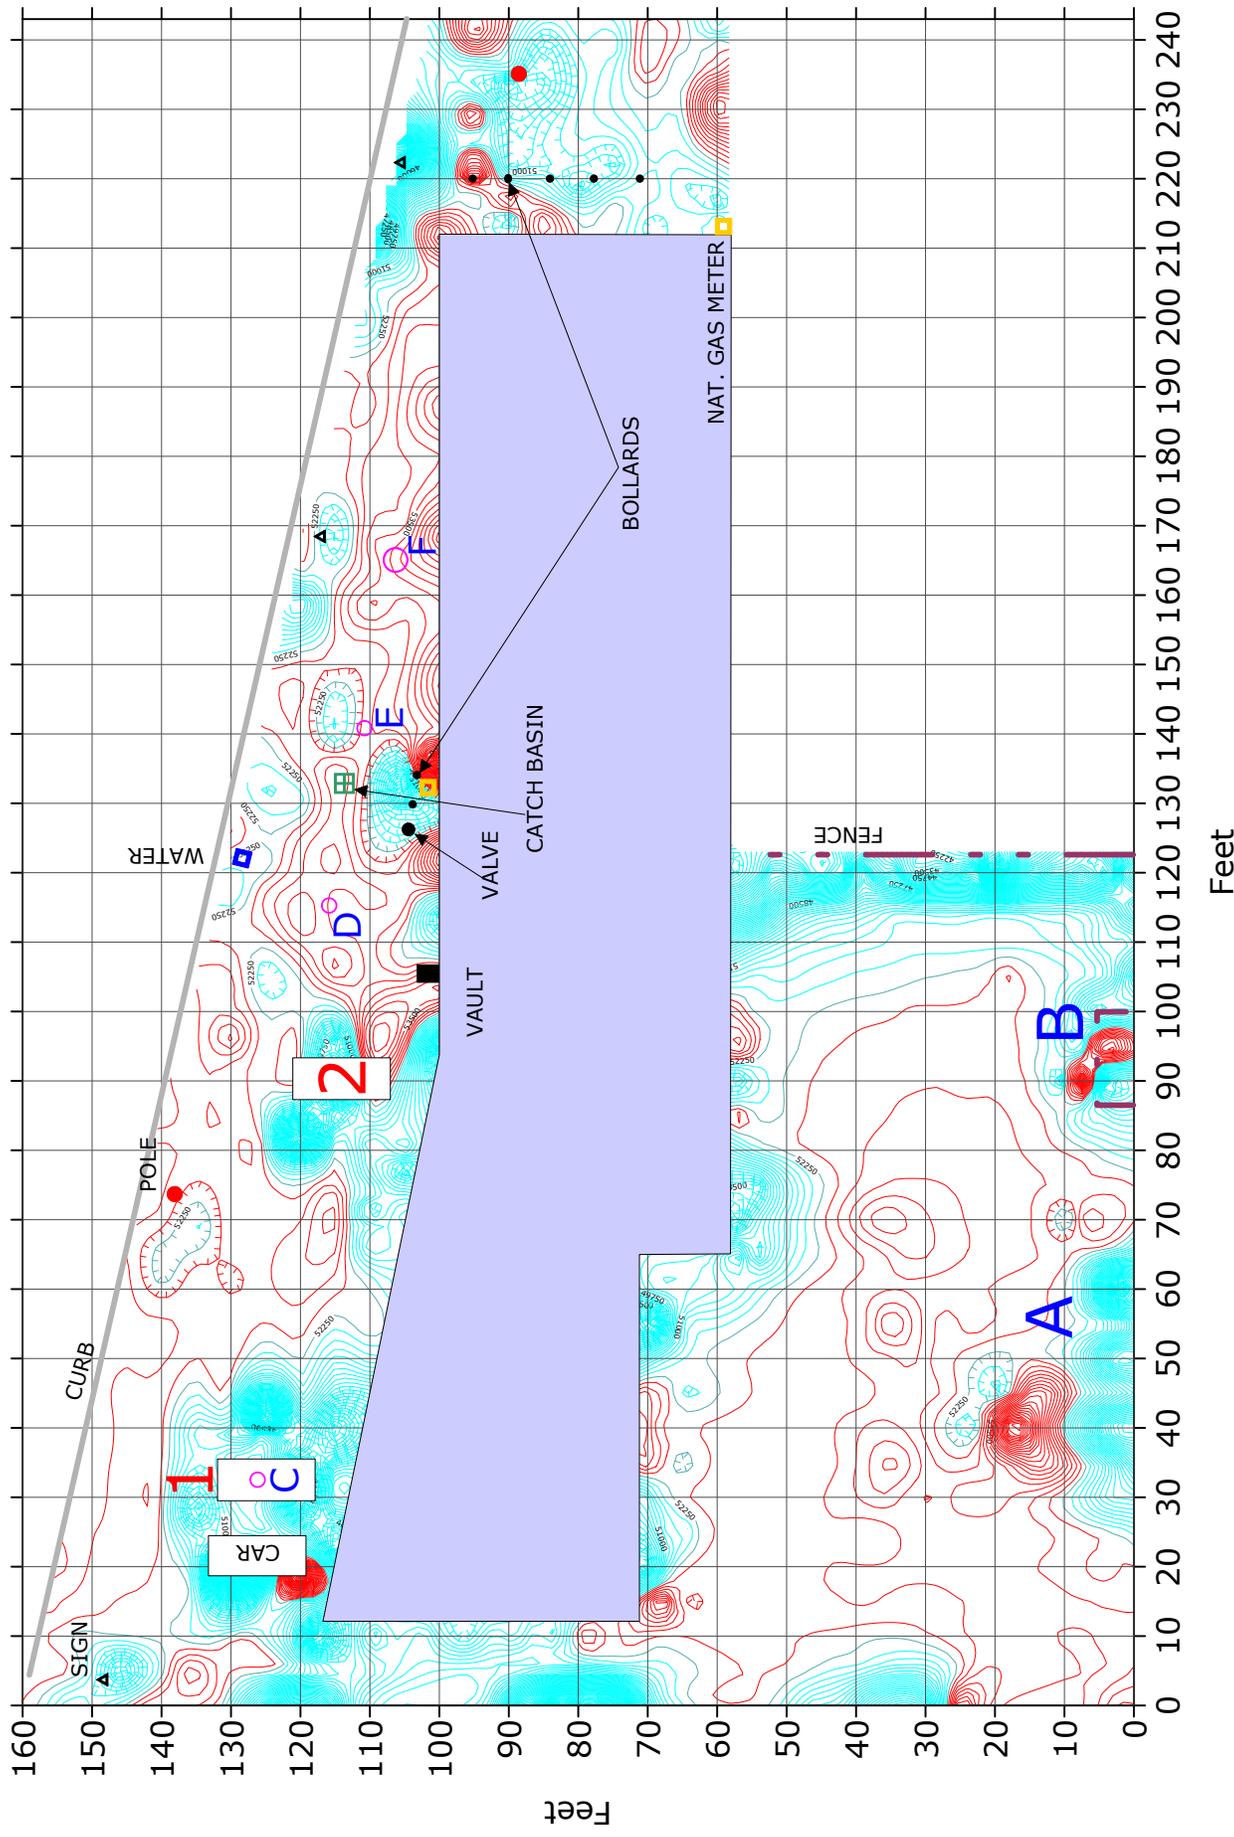
FIGURE	Magnetic Contour Map - C.I. = 250 nT	
	Project: 141111	Vacant Building 8114 SE Division Street Portland, Oregon
	Drawn by : NT	Prepared for: AAI Consultants
		Survey Date: November 26, 2014

The colored magnetic contour map is shown in Figure 2, contoured using an interval of 250 nT. Blue contours are generally caused by ferrous objects situated above the magnetometer sensor. Red contours are produced by ferrous objects below the sensor, including surface features and buried objects. USTs produce red-colored contours.

Several large anomalies were detected but most are caused by surface features.

Anomaly B is caused by a metallic fence/trellis system for berry plants.

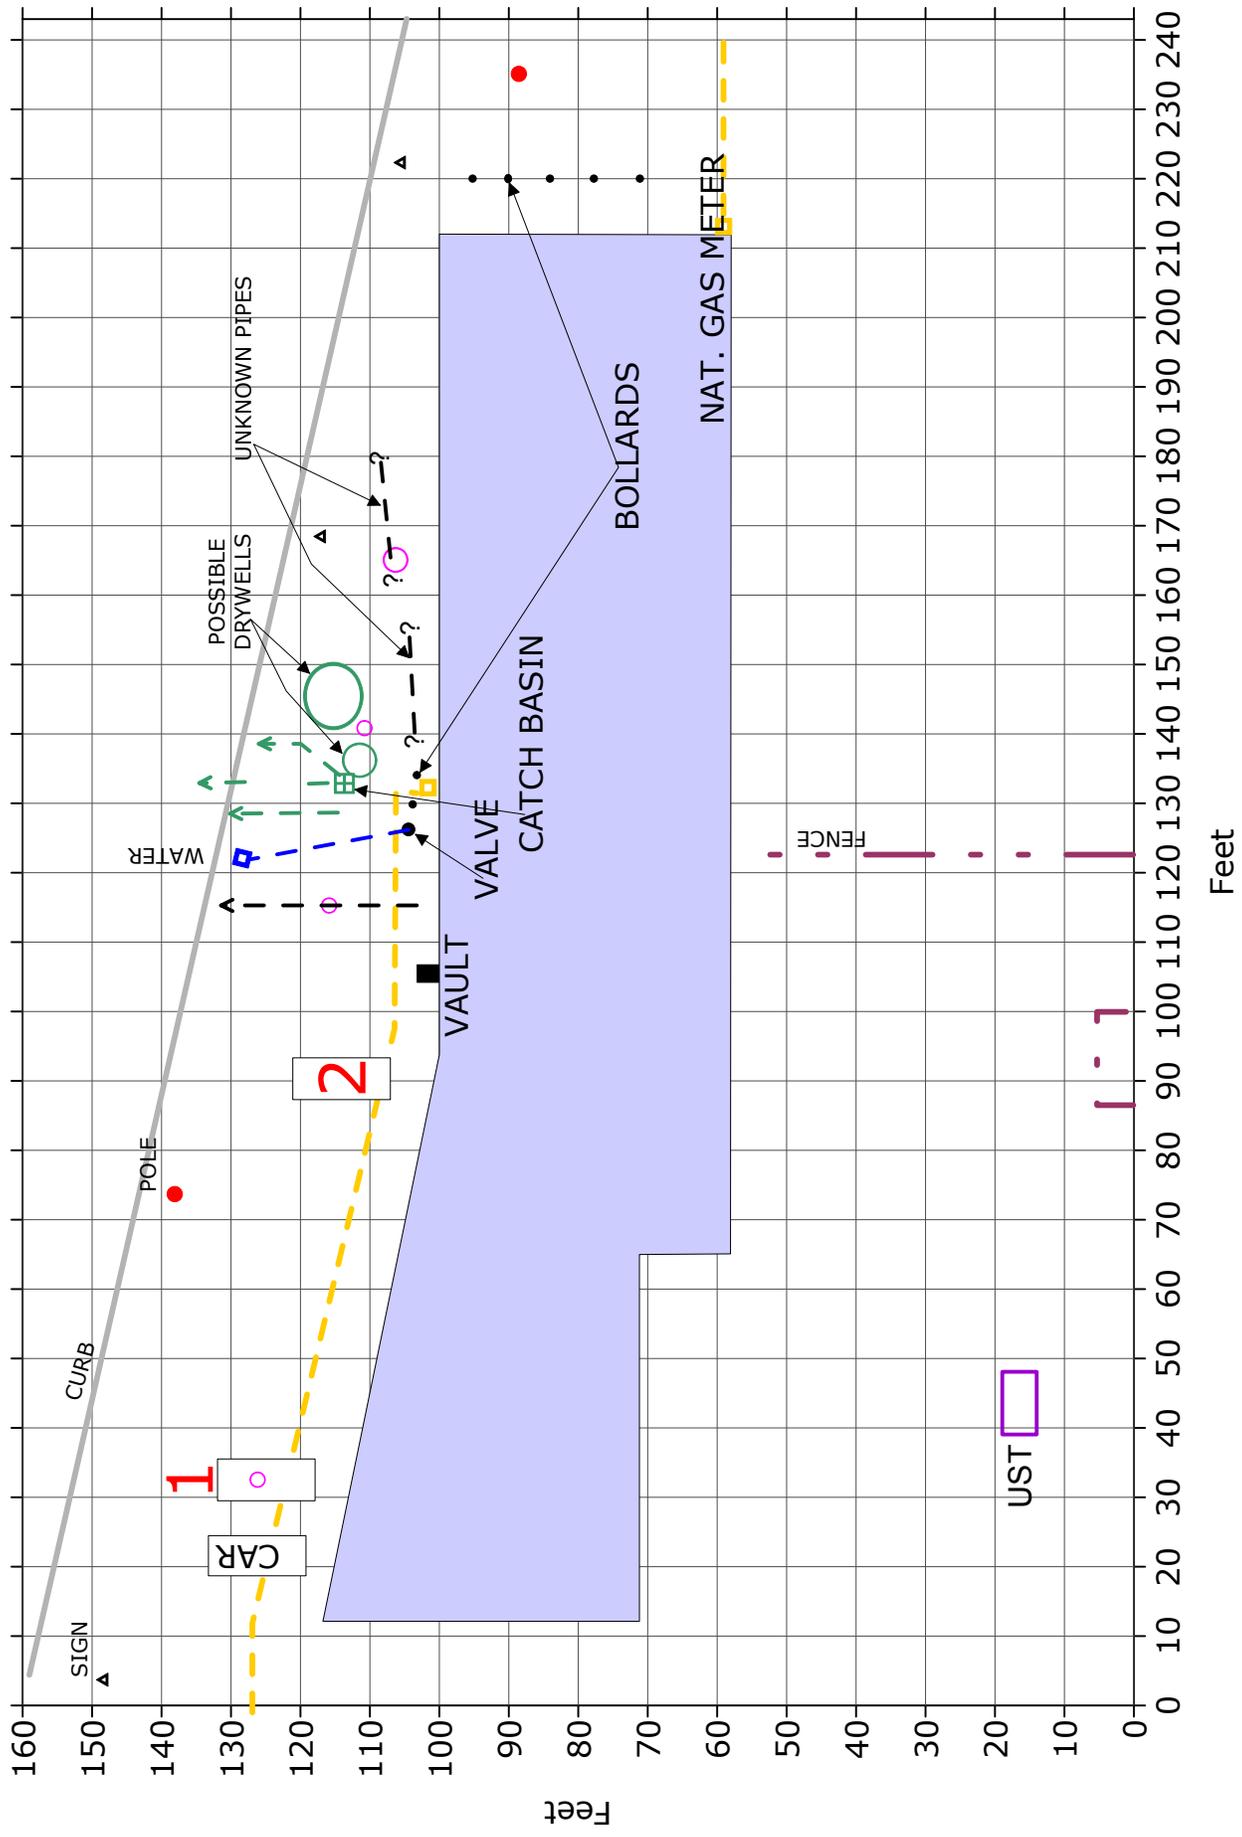
FIGURE 3

One buried, ferrous object that is interpreted to be a UST was found in the grass-covered lot south of the building. No other suspicious objects were found, including the areas marked by the utility locator. Two possible drywells were detected near the catch basin.

Magnetic anomaly A is interpreted to be caused by a buried UST, measuring 5 feet by 9 feet and buried 12 inches below the surface. It is shown in figure 3, an interpretation map of our results. It was touched using a metal soil probe.

Interpretation Map
