## Our landfill legacy

Metro-area landfills closed since 1960 and their impact on the region's urban and natural environment

March 2004

Prepared by Engineering  
and Environmental Services  
Solid Waste and Recycling  
Department

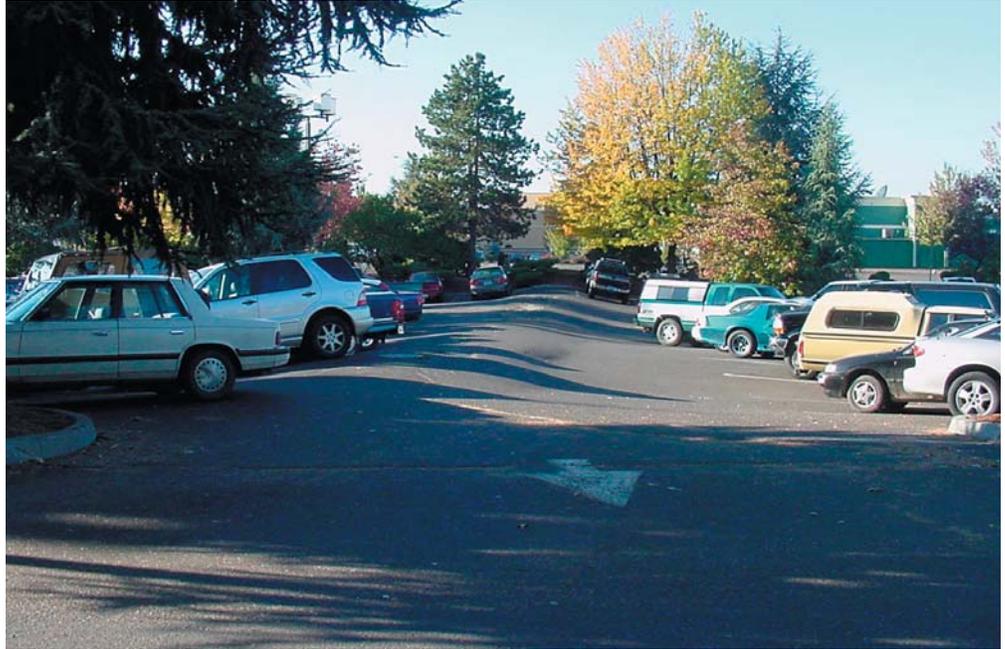
**Above – The undulating surface of a hotel parking lot in north Portland is evidence of an unstable landfill beneath the pavement.**

Hayden Island Drive was originally constructed in the early 1970s, and was rebuilt in the mid 1980s owing to settlement failure [16 (Heller Real Estate, 1992)]. While working on Hayden Island Drive, Multnomah County Public Works encountered “garbage” beneath the road in the immediate area of what used to be the Red Lion Hotel, the U.S. Bank Building, and extending westerly to the east end of the mobile home park [16 (Heller Real Estate, 1992)]. Test pits were dug along the eastern border of the mobile home park, and what appeared to be household garbage was found at depths between 4 and 8 feet below grades in 4 of the 6 test pits [16 (Heller Real Estate, 1992)]. Metro staff visited a hotel parking lot, and noted the rather dramatic undulations due to differential settlement. (See pictures below, and on the report cover.)

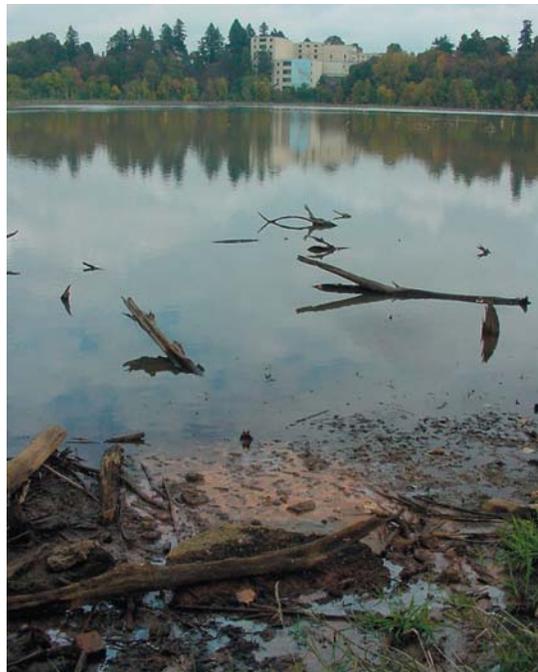
**Left – Oaks Bottom Wildlife Refuge shows signs of possible seepage from a 1970's landfill.**

During a recent Metro staff visit to the site in October 2002, however, discolored seepage was greatly in evidence at the bottom of the banks on the edge of the landfill. (See colored photo on front cover of this document.)

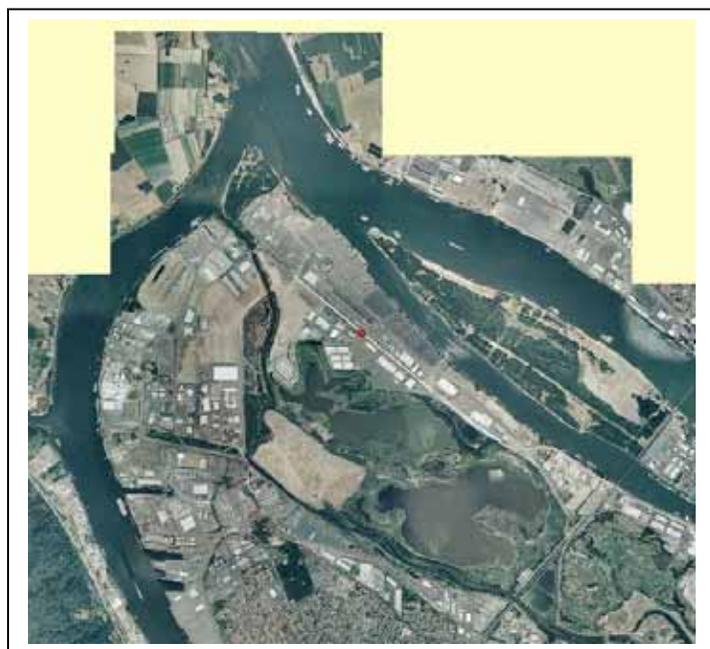
DEQ reports that despite engineering controls around the landfill perimeter some signs of leachate seepage can still be observed, and is concerned that leachate-contaminated shallow groundwater may be entering the sloughs or lakes. Contaminated sediment in the Columbia Slough is from many upstream sources, which may include landfill leachate seepage. Groundwater samples from some monitoring wells surrounding the landfill contain high concentrations of non-hazardous landfill contaminants and low concentrations of hazardous substances. The highest concentrations of all contaminants are found in the shallowest wells. Groundwater concentrations in general have been declining over the years. [6]

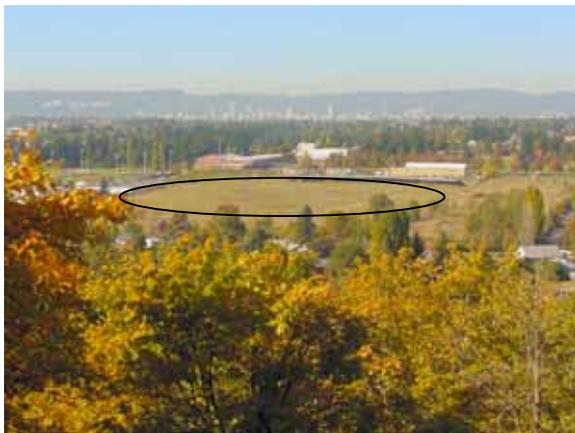
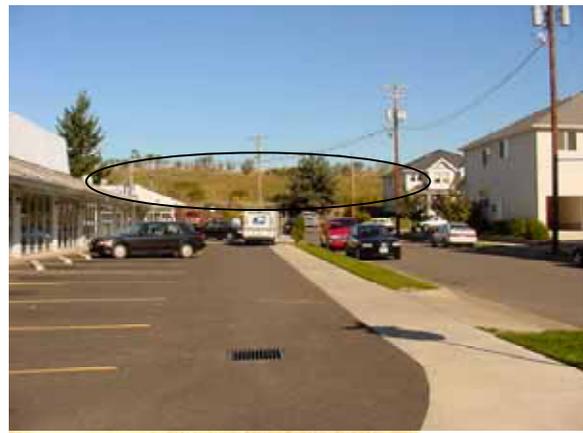
**Comments:** Pictures of the former site (note circled sections in photos) indicate the proximity of buildings to the landfill today. The first photo was taken facing west from Rocky Butte, and the second photo (taken facing north from NE Russell and NE 84<sup>th</sup>) shows the slope at the edge of the former landfill site. Surrounding land use is generally commercial and residential, with homes on the east and north edges of the former gravel pit which was landfilled [5].

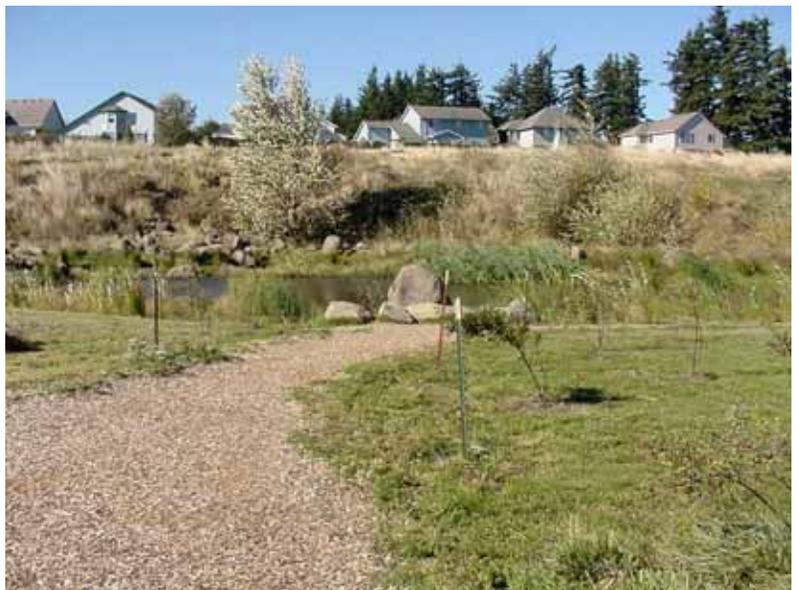
In 1980 the City of Troutdale acquired the property, and closed the partially full landfill. The remaining disposal capacity was filled gradually with soil, rock, various inert wastes, shredded tires, and some loads of petroleum-contaminated soil. The City allowed their original closure permit to expire in 1995, and was sited with a compliance violation in 1998 [47]. In 1999 the groundwater monitoring data indicated that the landfill leachate had affected the upper-most aquifer beneath the site [47]. The former Troutdale Landfill is now Sunrise Park. A picture is shown to the right. The proximity of residences can be seen in the photograph.

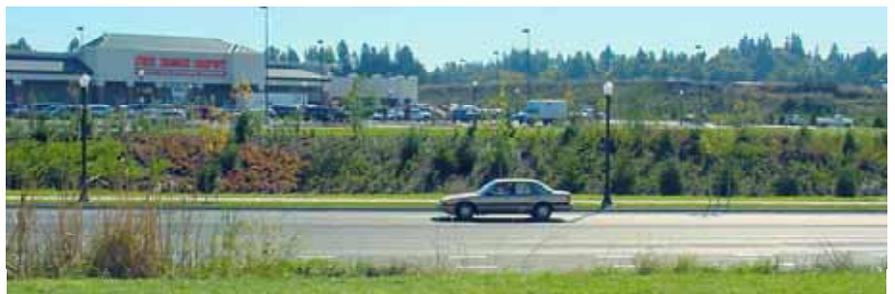
Twenty-three monitoring wells have been installed in the area. Groundwater is monitored semi-annually, and surface water in Clackamette Lake and Abernathy Creek are also periodically monitored. [6]. The site currently has a large retail store (Home Depot) built on top of it.
