Non-residential Refill Rate Study

Economic & Land Use Forecasting
Measurement Program

October, 2011

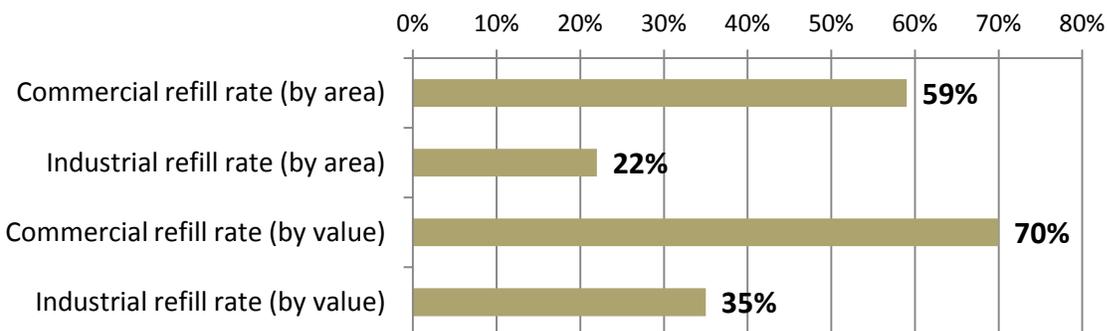
Figure 1. 2001- 2007 Non-residential Refill Rates

Of the 3,363 building permits reviewed, 1,742 were found to have added new capacity in the form of new building structures or additions. For these 1,742 permits, the non-residential refill rate was calculated to be 59% for commercial development and 22% for industrial development when measured by square feet of added capacity. In contrast, the refill rate measured through permit value was somewhat higher at 70% for commercial development and 35% for industrial development.

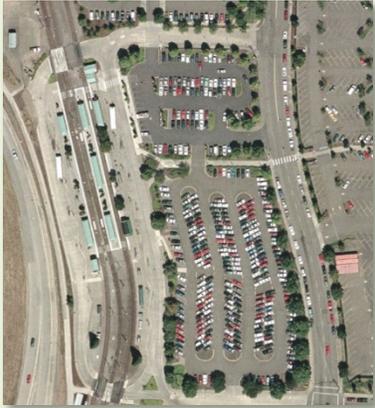
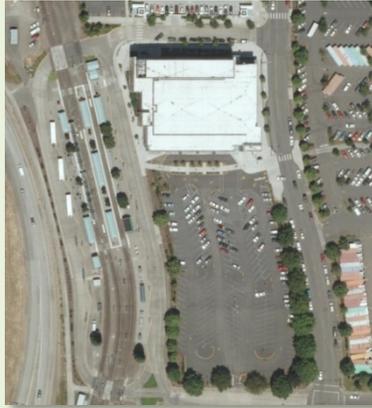
Figure 2. Infill Development Example

Non-residential refill is a term that captures two types of activity: redevelopment and infill. Infill construction (Figure 1) is on land previously classified as developed, but which does not require demolition of an existing structure. Infill may result from dividing developed parcels or from building on land which is used for parking. Redevelopment (Figure 2) is construction that occurs after demolition of an existing structure on land also previously classified as developed. These categories are contrasted with development on land previously classified as vacant (Figure 3).

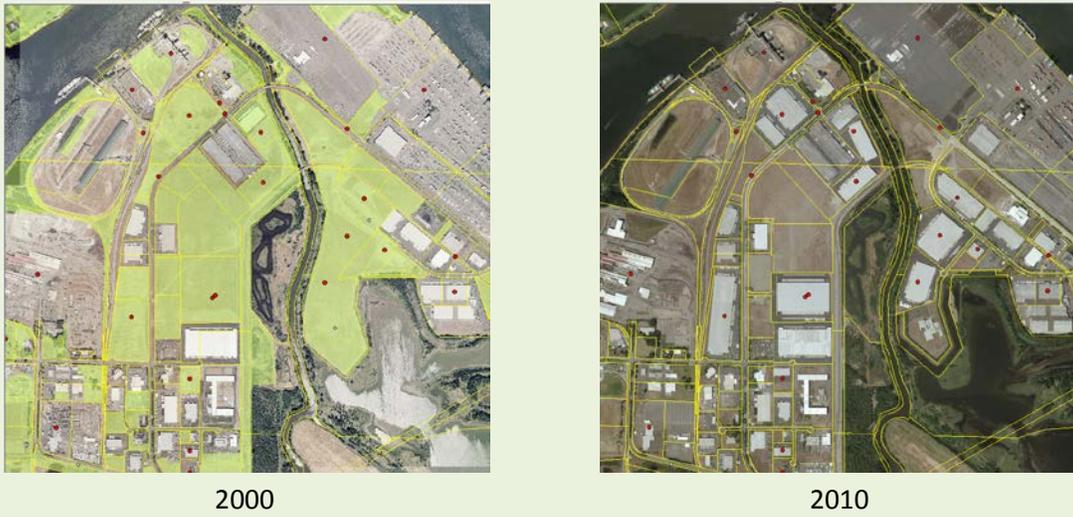
Figure 5. Industrial Development north of Portland's Rivergate area

Much industrial development occurred on large tracts of vacant land. The new structures in this image were among the largest recorded in the permit audit.

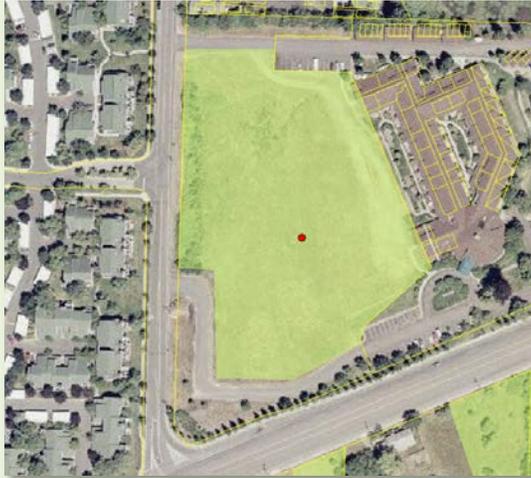
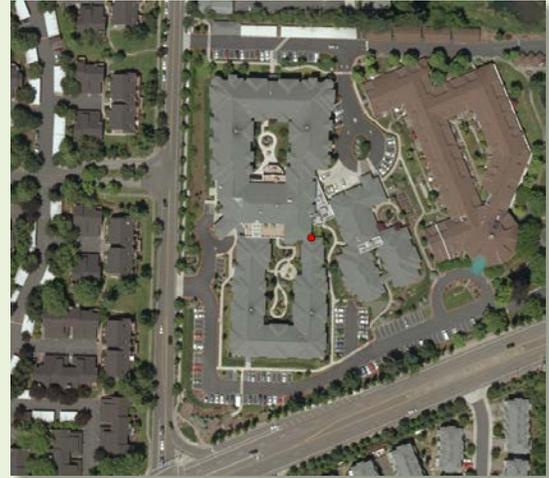
Figure 6. Development on Vacant-Infill land

The GIS Vacant status for this permit is “Vacant;” the Economic Vacant Flag for this development is “Vacant-Infill” because it is in a primarily built-up area.

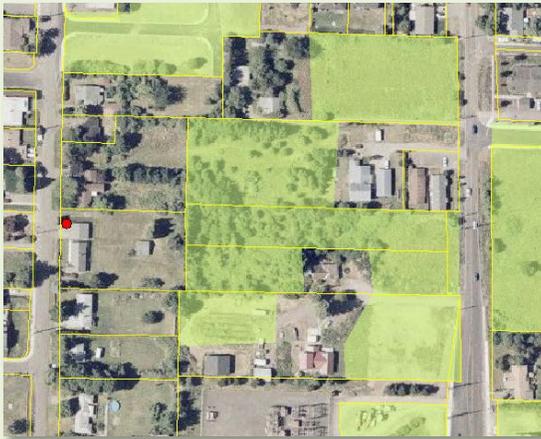
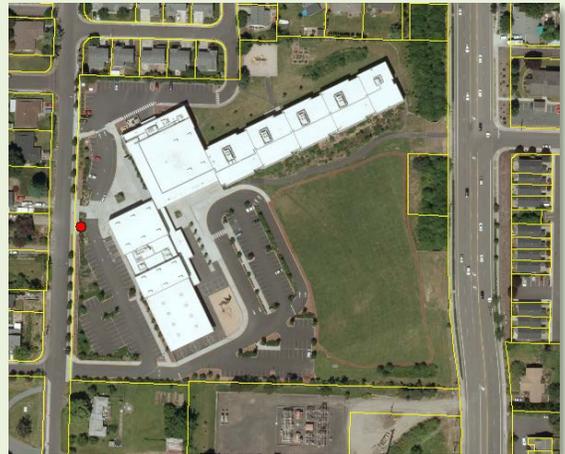
Figure 7. Development Spanning Vacant and Developed Lands

The GIS Vacant status for this permit is “Developed;” the Economic Vacant Flag for this development is “Developed.”

A small number of records are marked in opposite “Developed” or “Vacant” categories for the two vacant statuses because of the difference in definitions. Table 7 shows a cross tabulation of the **Economic Vacant** versus **GIS Vacant** for 1,742 permits with new capacity used to estimate refill rates. The majority of these differences are attributed to permits for locations that were classified as vacant in the 2000 inventory, but in which there was previous development (see Figure 7 and Figure 8 for examples.)

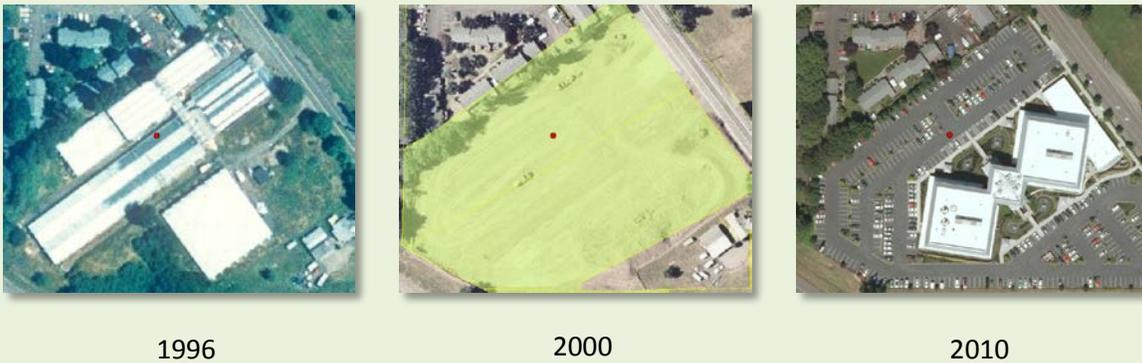
Figure 8. Redeveloped Land classified as GIS Vacant

The GIS Vacant status for this permit is “Vacant;” the Economic Vacant Flag for this development is “Developed” because there is evidence of previous development.

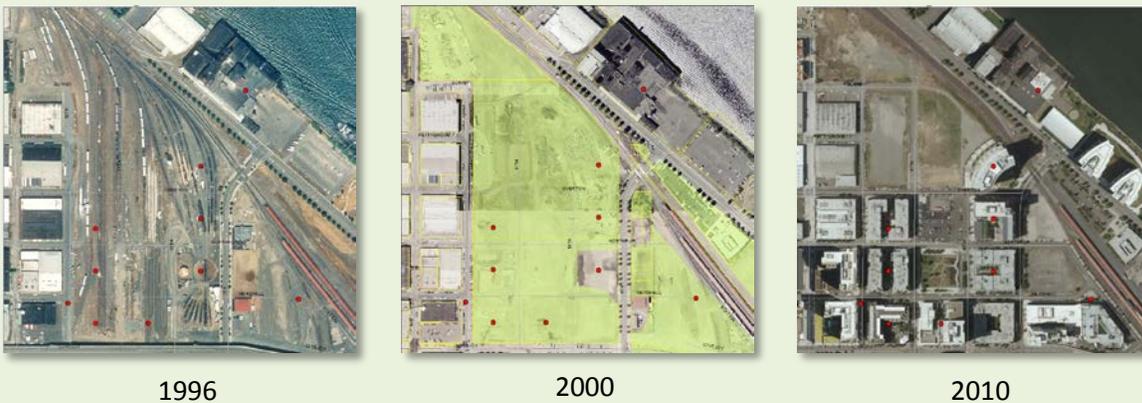
Figure 9. Redeveloped Land classified as GIS Vacant in the Pearl District

Much of the redevelopment of the Pearl district that occurred in the time-frame of this study occurred on land classified as Vacant in 2000, but which had previous industrial uses.

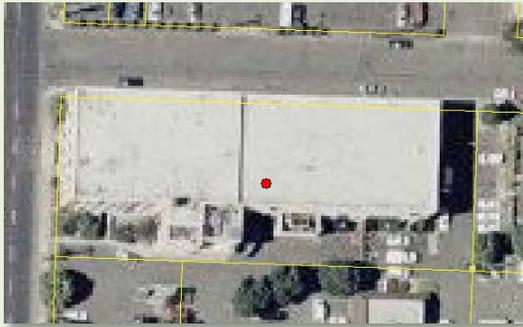
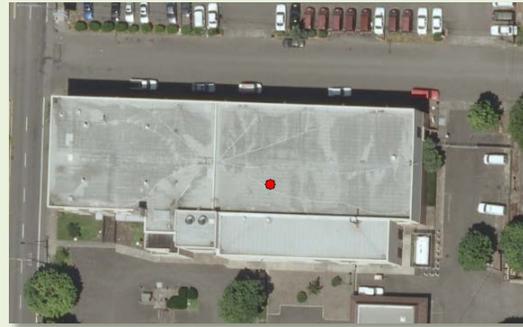
Figure 10. New Capacity Through Addition

The observed addition on the south side of this building yields to a New Capacity flag of "Addition."

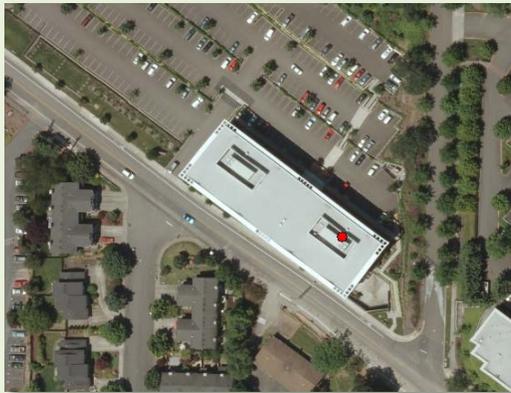
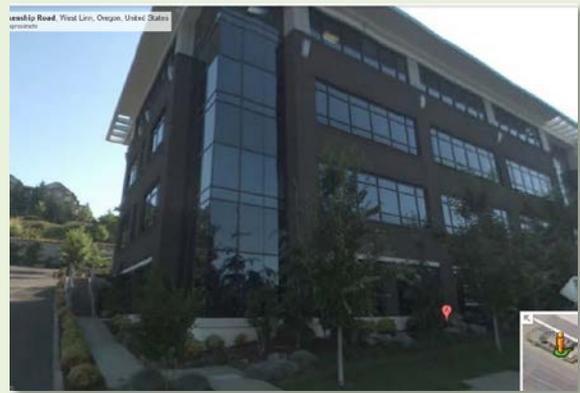
Figure 11. Estimation of permit square footage

The building footprint for this permit is 18,851 square feet and there are 4 stories in the building. Thus, square footage for this permit is recorded as 75,404.

New square footage is estimated for each permit that has new capacity. The square footage is estimated as the area of the building footprint multiplied by the number of stories in the structure. Special cases in estimating square footage include:

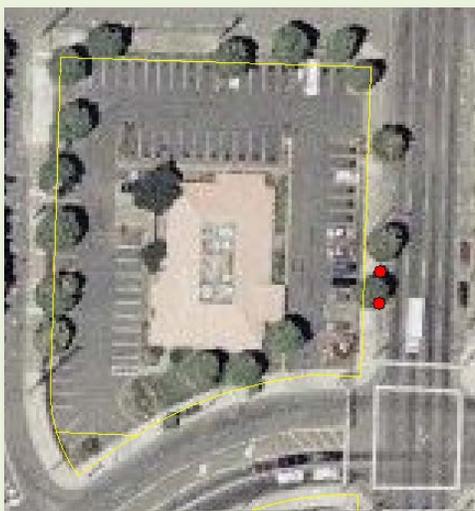
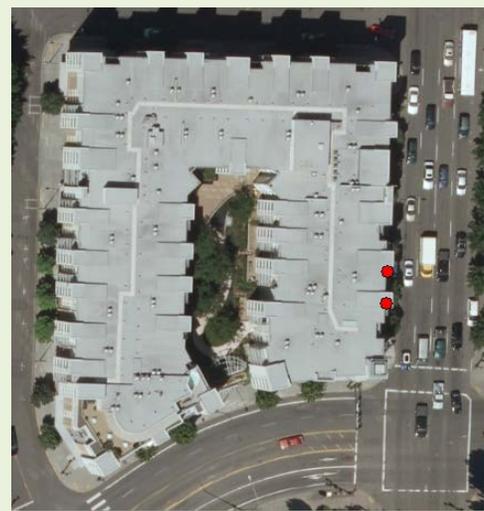
Figure 12. Teardown prior to development

The teardown flag is a binary flag indicating whether the site of development had a structure torn down prior to the development associated with the permit under review. This includes both entire structures and partial tear-downs. The teardown flag is not used in calculating the refill rate, but is captured as an auxiliary attribute for database checking.

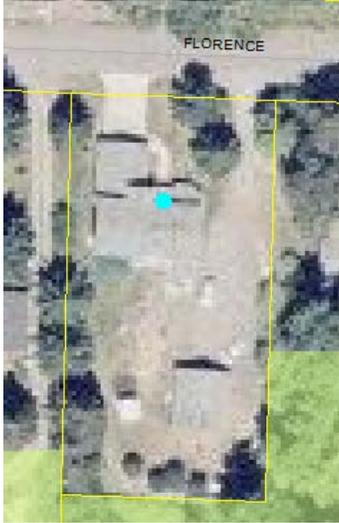
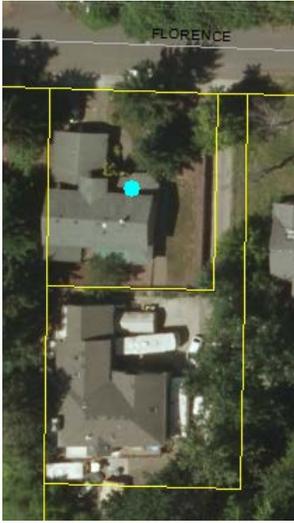
Table 17. Examples of development prior to address assignment

Permit Address	Real Address	Geocoding Result
37208 SW Florence Ln	7206 SW Florence Ln	Address matched with score of 100% to wrong parcel.

The cyan dot in each image shows geocoded permit location of for development on the subdivided parcel.
2000 imagery & tax lots	2010 imagery & tax lots

It was observed during the audit process that when lots were newly divided or developed, the development site often did not have a physical address at the time the permit was issued. In many of these cases, the address of the pre-divided lot or adjacent lot was with the same owner was entered as the permit site. The resulting permits are matched to an incorrect but nearby tax lot. Correcting the geocodes location of these permits through automated means is unlikely.

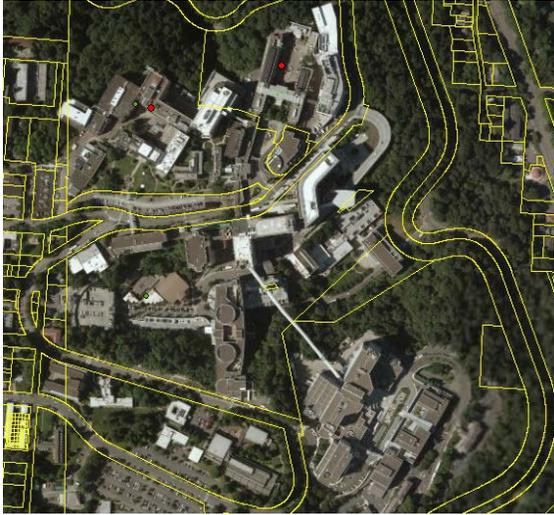
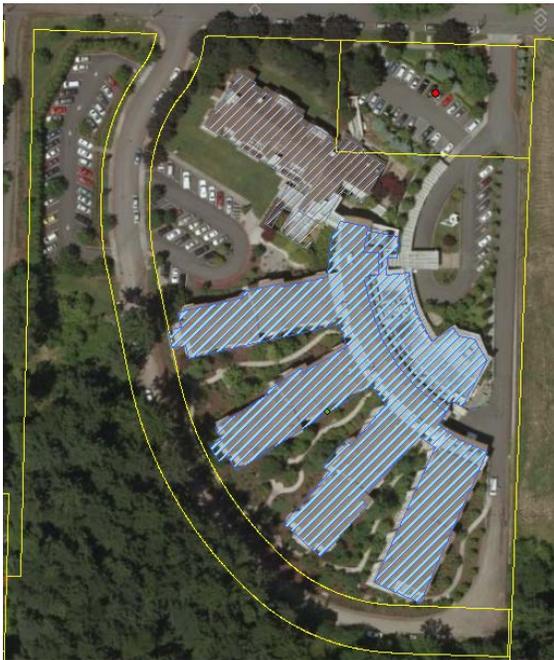
Figure 13. Examples of real-world address ambiguity

14 permits for development on various buildings at OHSU all geocoded to one of two central locations highlighted in red in the image.

The permit for this development geocoded to the lot with the red dot instead of the lot with the primary development. In this example, the lots are reasonably compact and thus the geocode is not very far from the development location. In other cases observed, the geocode location can be quite far from the development because the lot sizes are much larger.

This error was observed on both mid-scale developments and large multi-building campuses (e.g. high schools, shopping centers, hospitals, etc). Additionally, permits for large campuses may be issued with a central headquarters address as the site address instead of the building where development has occurred.

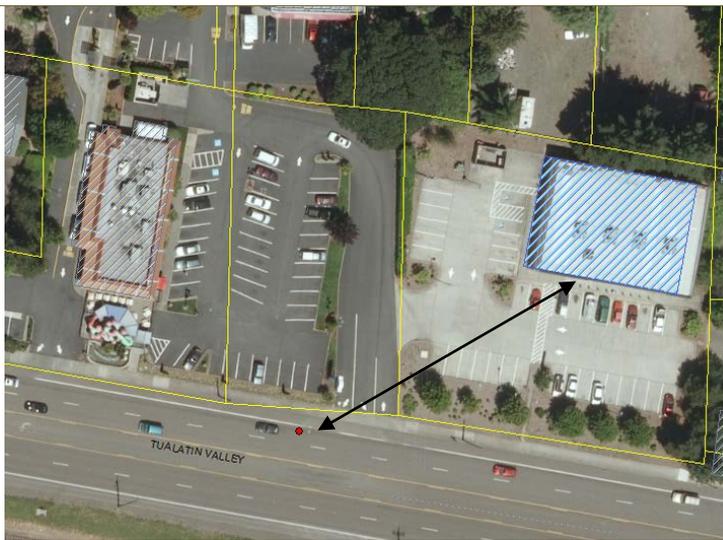
Figure 14. Examples of error in locator data

The highlighted permit geocoded to a street-level match because the 2008 tax lot file had an error in the site address. The permit matches the 2010 tax lot file and correctly geocodes with the current locator file.

The number of these errors is estimated to be very low, however the error can be easily resolved geocoding with a current locator.
