# APPENDIX C

## BROWNFIELDS CASE STUDIES

# BROWNFIELD CASE STUDY ANALYSIS

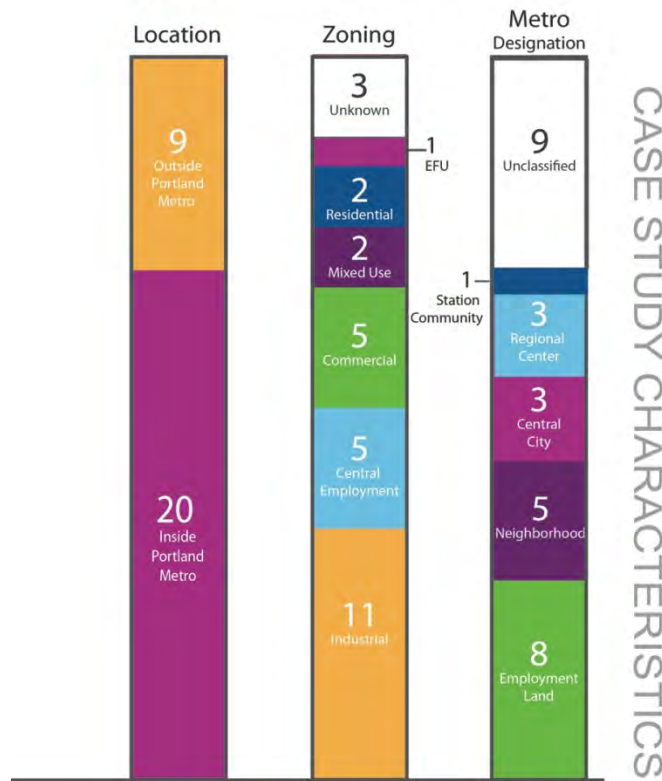
## Of 29 Sites.....

The case study analysis evaluated 29 contaminated sites, more than half of which yielded qualitative survey responses and personal perspectives. A summary of general site characteristics are listed in the chart below:

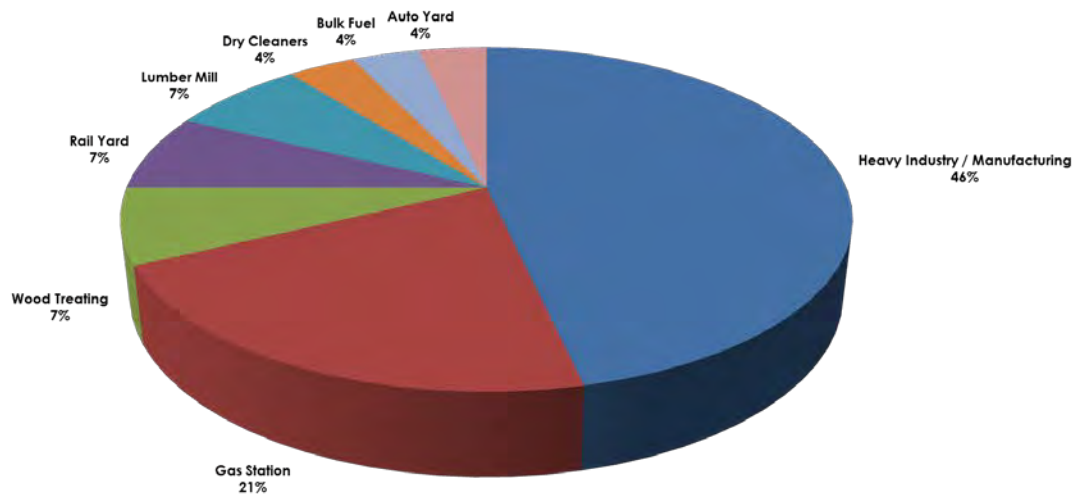
**Figure 2-1. Historical Uses of Case Study Properties**

Contamination on brownfield properties is commonly related to historical activities that occurred before the passage of modern environmental laws. The case study projects represent a wide range of past uses and contamination types that are representative of the industrial history of the Portland Metro region. The most common historical uses on the case study properties were heavy industry/manufacturing and gas stations, representing 46 percent and 21 percent of the case study sites respectively (See figure 2-1). The industrial/manufacturing category broadly includes processing of raw materials and chemicals, machining, and fabrication.

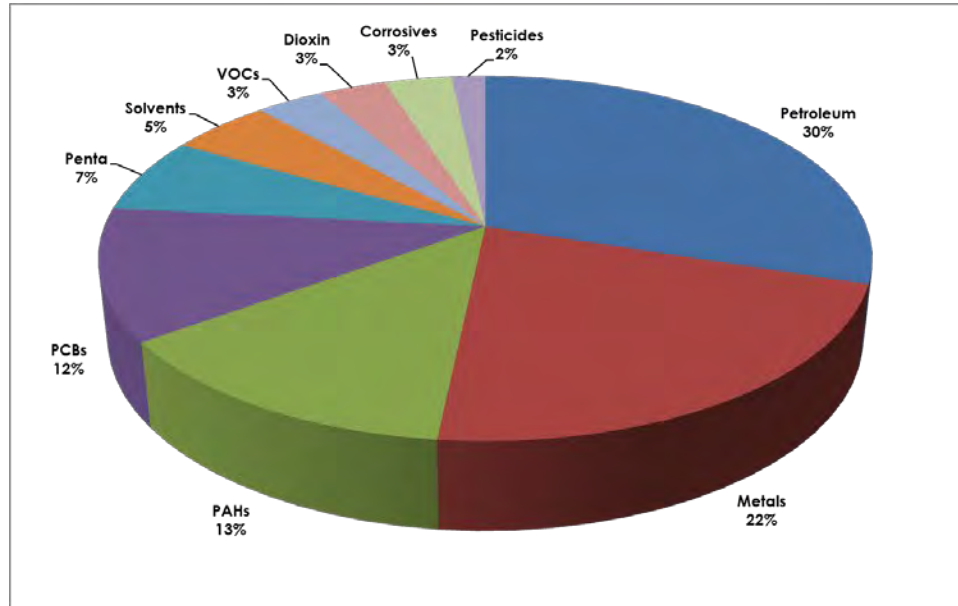
**Figure 2-2: Soil Contaminants in Case Study Properties**

Contamination on the identified brownfield properties is commonly found in soil, but can also occur in groundwater and river sediments. The most common contaminants in soil in the case study projects were petroleum, metals, polycyclic aromatic hydrocarbons (PAHs), and polychlorinated biphenyls (PCBs). The hazardous materials are associated with the use of heavy machinery and automobiles. Petroleum and PAHs can be released from storage tanks, spills, or leaks from machinery. Metals contamination in soil can occur from the friction of machinery parts. (See Figure 2-2)

The prevalence of these contaminants is consistent with the DEQ database of contaminated sites and aligns with findings of similar studies in Washington State and nationwide.

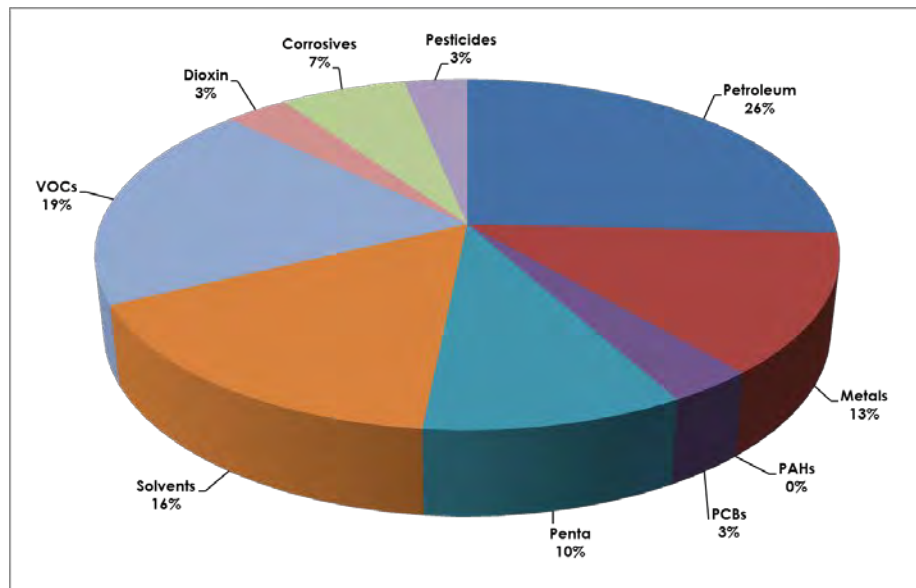
**Figure 2-3: Groundwater Contaminants in Case Study Properties**

Common contaminants in groundwater include petroleum and petroleum-related compounds including PAHs along with volatile organic compounds (VOCs) and solvents. These compounds tend to be soluble and leach into groundwater, while metals tend to bind to the soil. See Figure 2-3

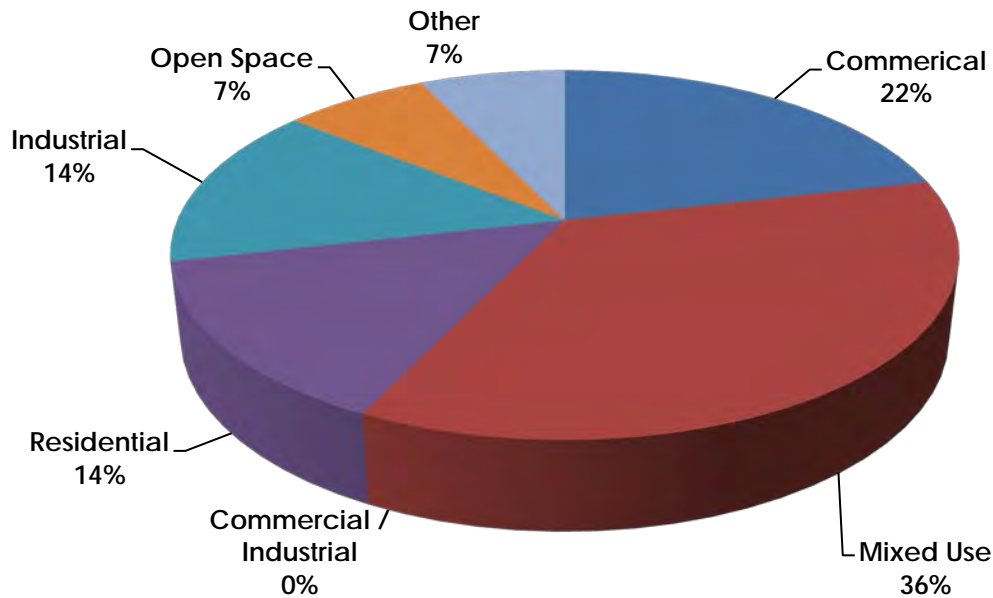
**Figure 2-2. Redevelopment Uses of Case Study Properties**

Approximately half of the case study projects have successfully been redeveloped to a new use. The most common redevelopment uses were mixed use and commercial (See figure 2-2). It is important to note that over 50 percent of the redevelopment projects represent a change in use type and zoning. These use changes were predominantly from an industrial to a commercial or mixed use.

The change in use from industrial to commercial and mixed use appears to be a major factor in the financial feasibility of brownfield projects. Though sufficient data to conduct this analysis was limited to just four case study projects, the findings have important implications. The cost of cleanup exceeded the value of the land in its historical use by 13-192 percent in three of the case studies (See table 2-2). The cleanup cost was only 3 percent to 43 percent of the land value after redevelopment. The potential to generate sufficient value to offset the cost of remediation is fundamental to the financial feasibility of brownfield projects. The change of use appears to be a common and effective strategy that creates value and drives redevelopment of certain brownfields. This analysis underscores the reported difficulty of redeveloping industrial brownfields for continuing industrial use.
