## **A PHASE I ENVIRONMENTAL SITE ASSESSMENT**

Tax Lots 1202 and 1203  
NW Civic Drive  
Gresham, Oregon

April 26, 2006

Project No. 6977

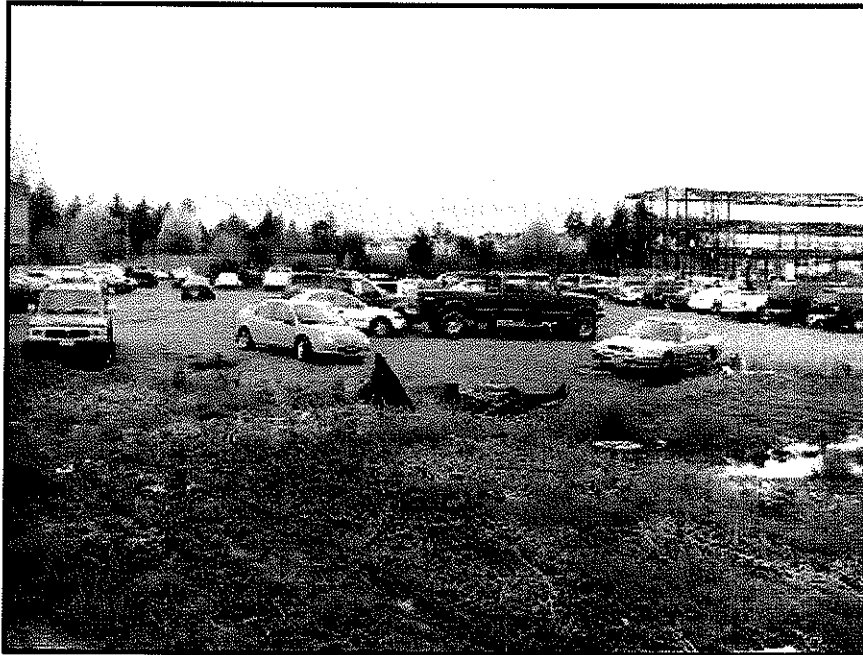
**Photograph No. 1**

The eastern portion of the subject property was covered with gravel and used for parking (Photograph 1). As such, the ground surface could not be observed and assessed for evidence of hazardous materials releases. In addition, the parking lot was crowded and much of the gravel surfacing was obscured from view by vehicles. However, staining was not observed on exposed areas of the gravel.

Comments: View of the eastern portion of the property from an adjoining rise.
