SW Corridor Project

Wetland Delineation Report

Prepared for: **Metro** 600 NE Grand Avenue Portland, OR 97232

November 2020

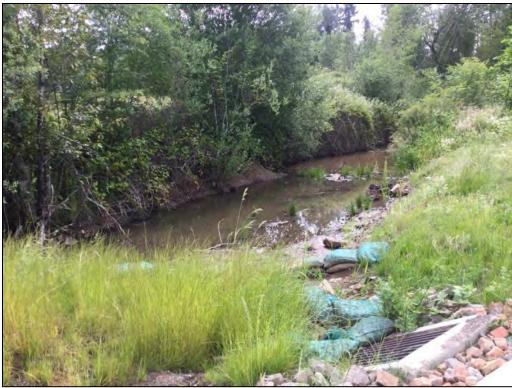
Photo PP-C1: Looking east at newly impacted and restored S-C1. Recent adjacent road and sidewalk construction appears to be the cause.

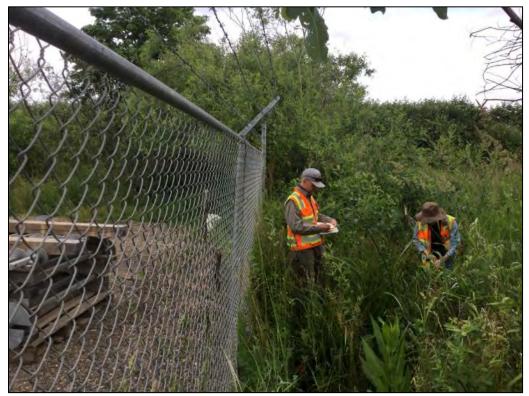
Photo PP-C2: Looking northwest along the boundary of Wetland C-1 at wetland Plot C1.

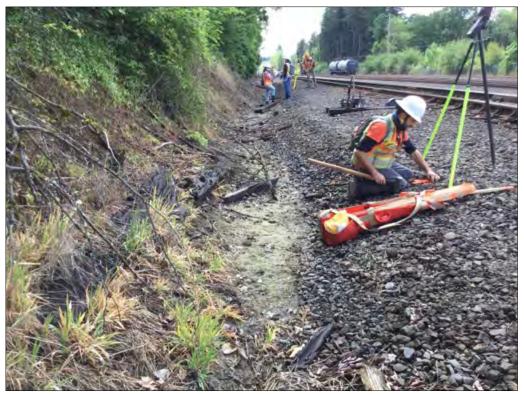
Photo PP-13: Looking southeast at Wetland W-Cc. Algal matting and soil cracking in foreground and Plots W-Cc1 (wetland) and W-Cc2 (upland) in background.

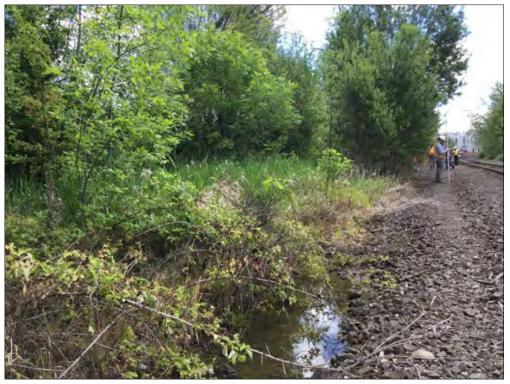
Photo PP-C14: Looking southeast at Wetland W-Cd, which is located between railroad berm and fill-slope of adjacent lot. Plot W-Cc1 (wetland) in center of photo and Plot W-Cc2 (upland) to east.

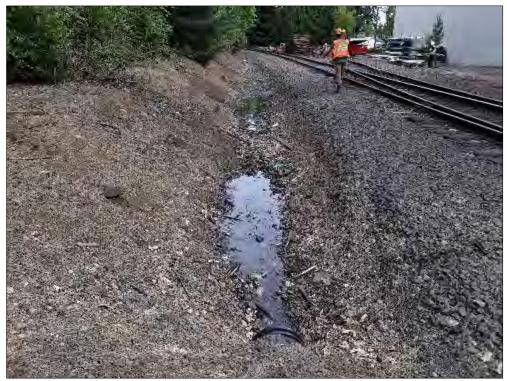
Photo PP-C20: Looking southeast at Railroad Ditch D-Cc from culvert. Ditch is located between railroad berm and adjacent upland slope. Some ponding present during the May 2020 site visit and recent indicators of flow including presence of litter and water staining.

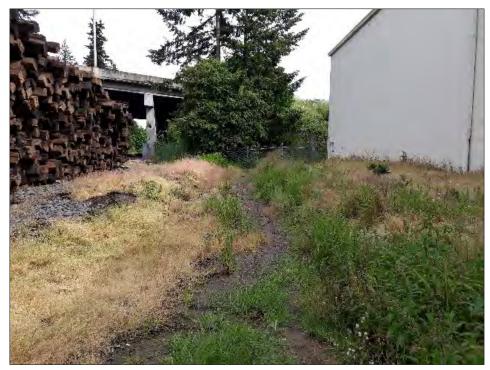
Photo PP-C21: Looking southeast at Ditch D-Cd located between railroad berm and adjacent development. Photo taken from start of ditch. Unable to determine connection of ditch to a City-mapped stormwater channel (flowing south along I-5) that is mapped beyond chain link fence.
