# Inspection Report

## Oregon Metro

**Property Address:**  
2517 SE 82nd Ave.  
Portland OR

<b>Date:</b> 10/17/2014	<b>Time:</b> 10:04 AM	<b>Report ID:</b> 20141017a
<b>Property:</b> 2517 SE 82nd Ave. Portland OR	<b>Customer:</b> Oregon Metro	<b>Real Estate Professional:</b>

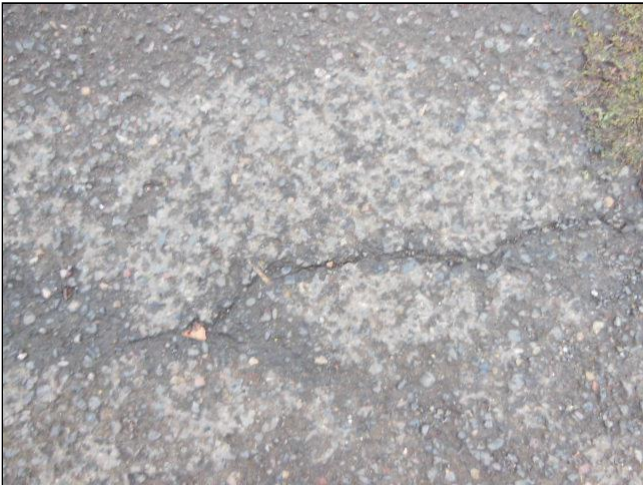
C. Item 1(Picture)

concrete walkway at front damaged, can be a trip hazard (near 82nd entrance)

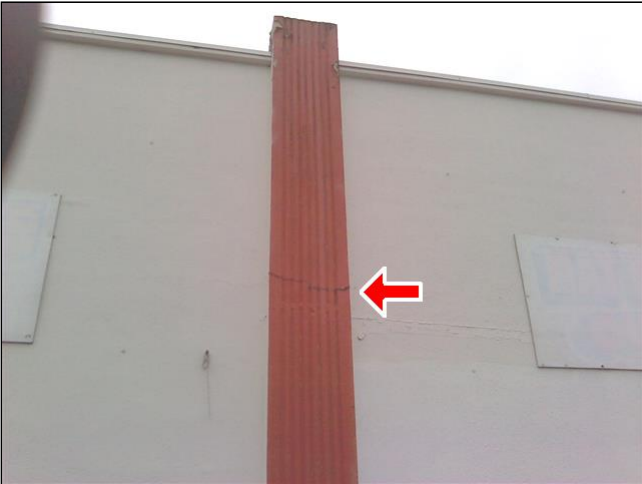
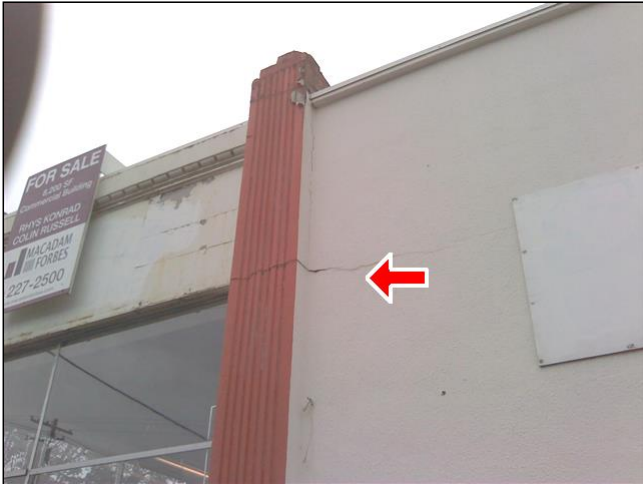
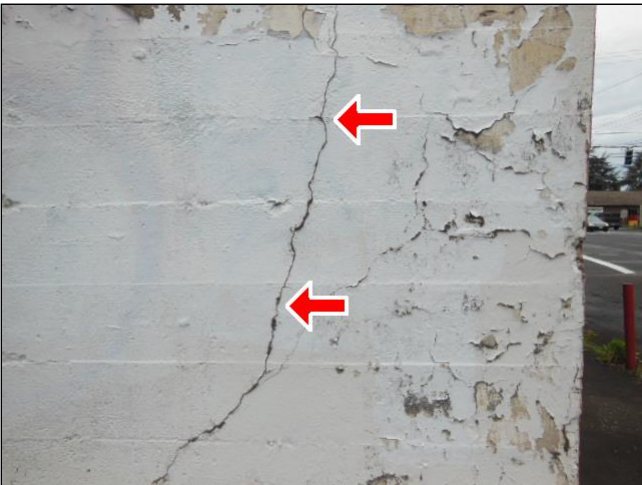
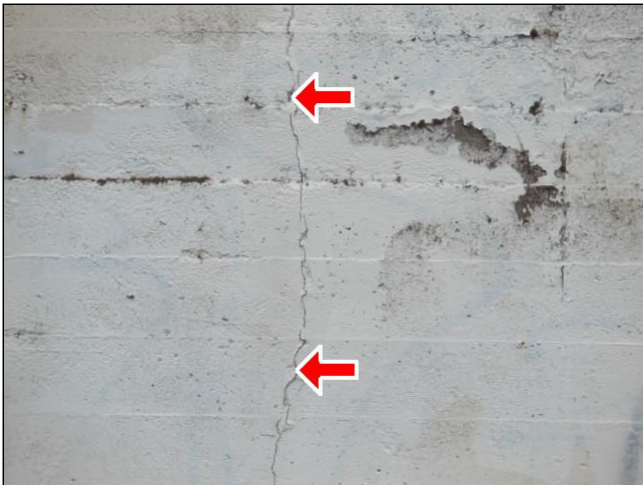
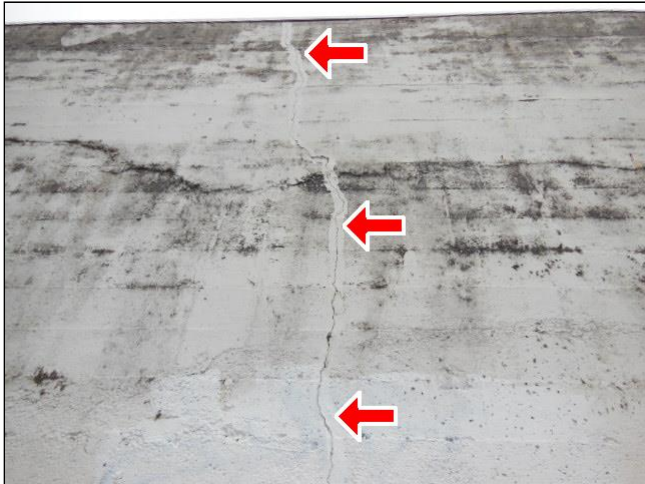
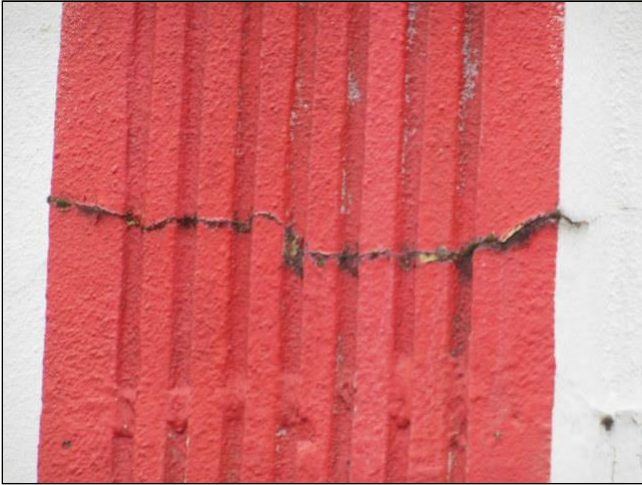
(1) Hairline settlement crack (typical) at exterior. These cracks do not appear significant to require repairs at this time. I recommend a structural engineer inspect further and repair if needed.

vertical cracks at the rear of the building do not pear in our opinion to be significant. There appears to be a horizontal crack across the front of the building (along division) Building section #1. This may only involve the exterior stucco but it may be more significant. Unfortunately, it is unlikely that This condition can be evaluated any further through non destructive means. Removal of a portion of the stucco and some of the interior framed out, lath & plaster wall may be necessary to get any better evaluation of this crack.

Infrared analysis of the crack from the building exterior does not show much entrapped moisture and therefore does not appear to be extensive.

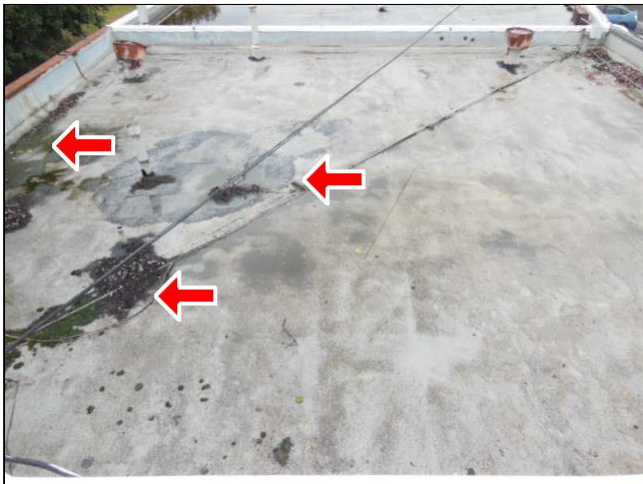
G. Item 3(Picture) 2, note patching
